IN THE CORONERS' COURT OF THE NORTHERN TERRITORY

CORONERS' FINDINGS ROAD DEATH 28 OF 2024

I, Elisabeth Armitage, Coroner, having investigated the death of a **61-YEAR-OLD CAUCASIAN MALE** and without holding an inquest, find that he was born on **11 July 1962** and that his **death occurred on 18 June 2024, at Lambrick Avenue, Johnston in the Northern Territory.**

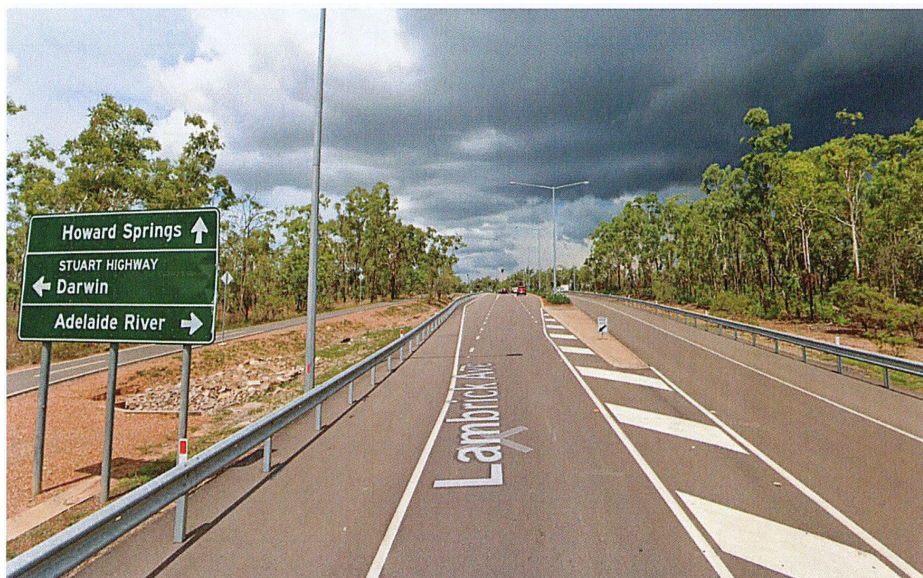
At about 5.54 am, the cyclist was captured on Department Logistics and Infrastructure (DLI) CCTV cameras approaching the Lambrick Avenue/Stuart Highway intersection. A short time later the CCTV camera panned away. However, he continued to ride on the broken white line between the left turn lane and the middle lane of Lambrick Avenue as though to proceed through the lights and cross the Stuart Highway.

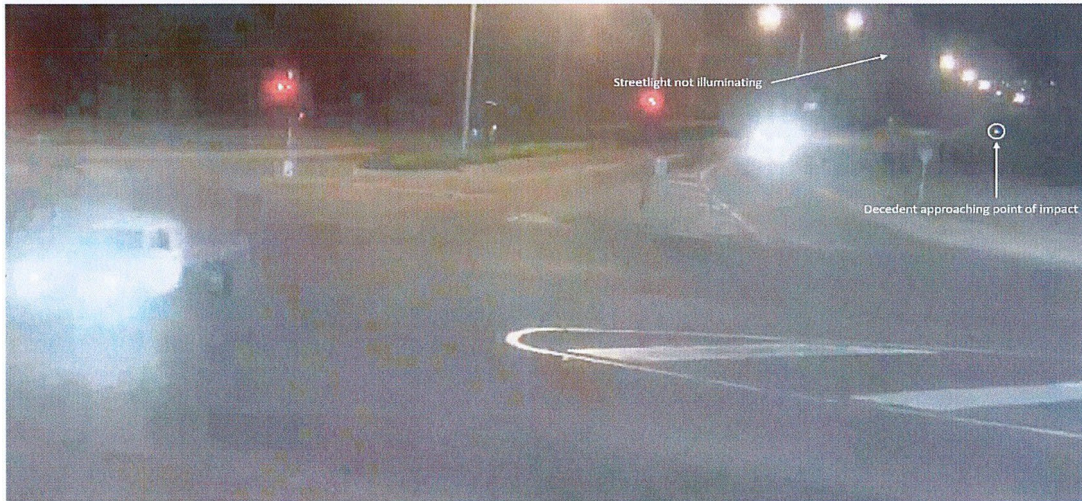
At this time the streetlight near where the crash occurred was not illuminated and at 5.54 am, traffic lights were red at the Lambrick Avenue and Stuart Highway intersection.

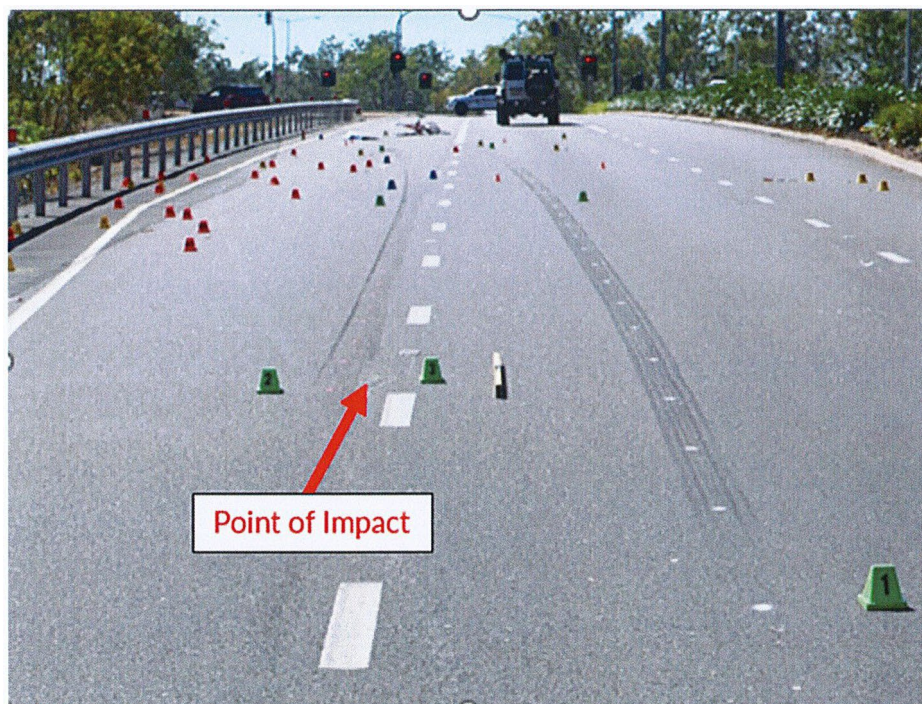
The front wheels of Driver 2’s Landcruiser locked up and the Landcruiser skidded for 4.53 metres and crashed into the rear of the cyclist. At impact the Landcruiser was travelling at 75 km/h. The cyclist was thrown onto the bonnet of the Landcruiser. The Landcruiser skidded to a stop 38.71 metres from where the skid commenced and the cyclist came to rest on the roadway 5 meters in front of the Landcruiser.

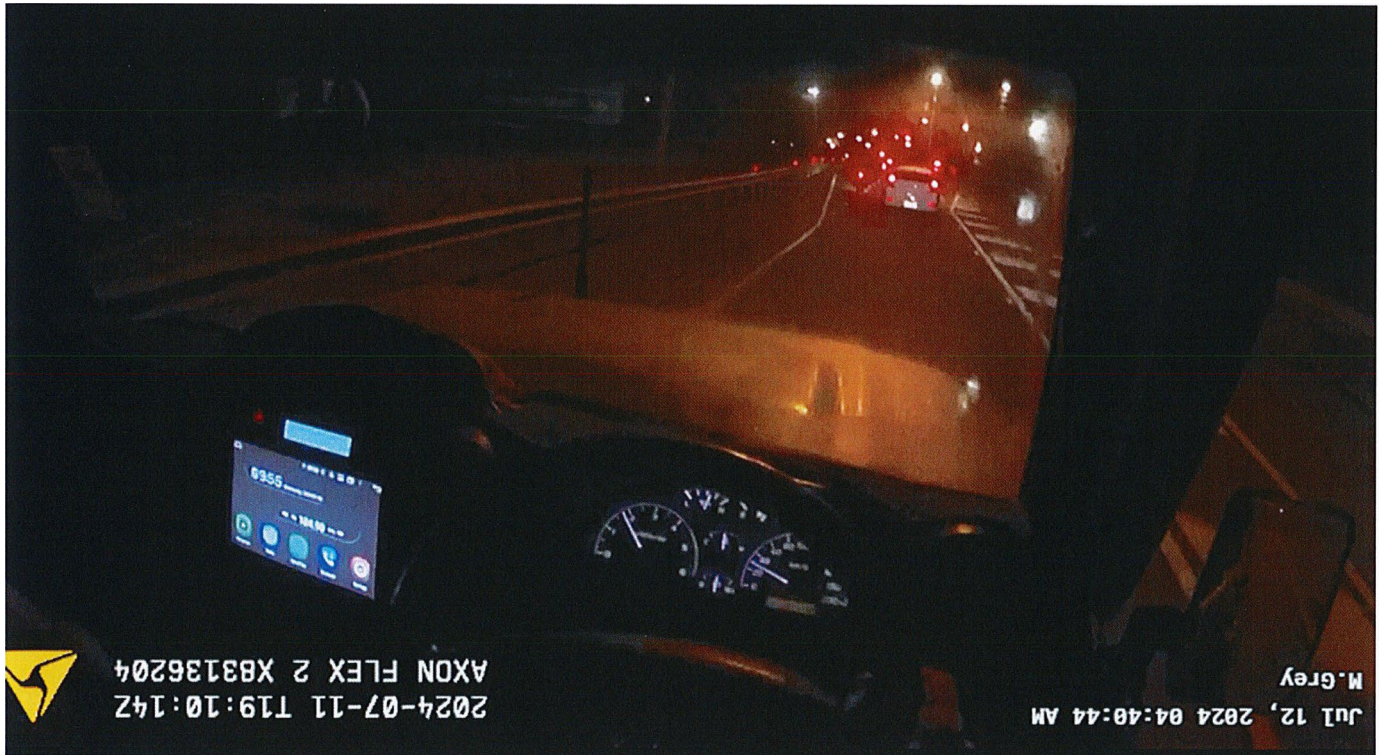
This re-nactment still image and all other images courtesy of Major Crash Investigators

The re-enactment demonstrated the image overload Driver 2 would have experienced with reference to the red bicycle taillight in contrast to the red traffic lights and break lights. It demonstrates just how difficult it was for Driver 2 to identify the cyclist (to the left of the braking car).
