CITATION: *Inquest into the death of Mitchell Thomas* [2026] NTCC 08

TITLE OF COURT: Coroners Court

CATCHWORDS: **Electrical house fire; public housing; electrical arcing in the roof space; smoke alarms; an audit of public housing for electrical safety in Alice Springs and Tennant Creek; major electrical faults; AS/NZS 3019:2022; cyclical maintenance; periodic electrical inspections; investigation of electrical fires; Electrical Safety Regulator.**

In the matter of an Inquest into the death of
MITCHELL THOMAS

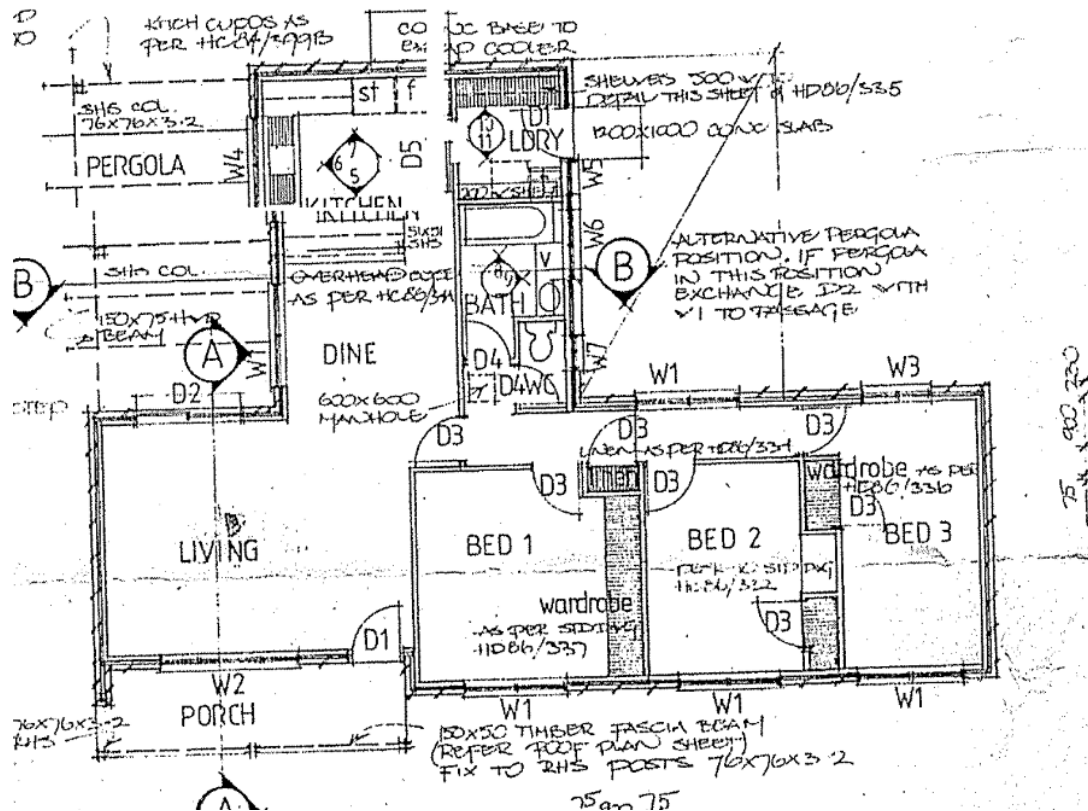
29. As already noted, the home was constructed in 1988. It was a single-storey, three-bedroom, one-bathroom brick construction with a corrugated metal roof. After the fire the home was demolished. Figure 1 is the floor plan.⁴⁴

30. Either at the time of or after construction of the house, an air-conditioning vent was installed in the “600 x 600 manhole” outside the bathroom and WC and marked on Figure 1 (**Air Vent**). The function of the Air Vent was to allow air brought into the home by the evaporative air cooling unit to escape from the interior of the home into the roof space.⁴⁵
31. There was agreement between Mr Denham, Mr Cox and Mr Swift as to the likely approximate location of the commencement of the fire, being within a small area of approximately 100mm in diameter within the roof space adjacent to the Air Vent.⁴⁶
32. Mr Swift was the first investigator to attend the home after the fire. Mr Swift took photographs of the home and the ceiling space in the immediate aftermath of the fire. Mr Swift’s photographs showed he had moved some of

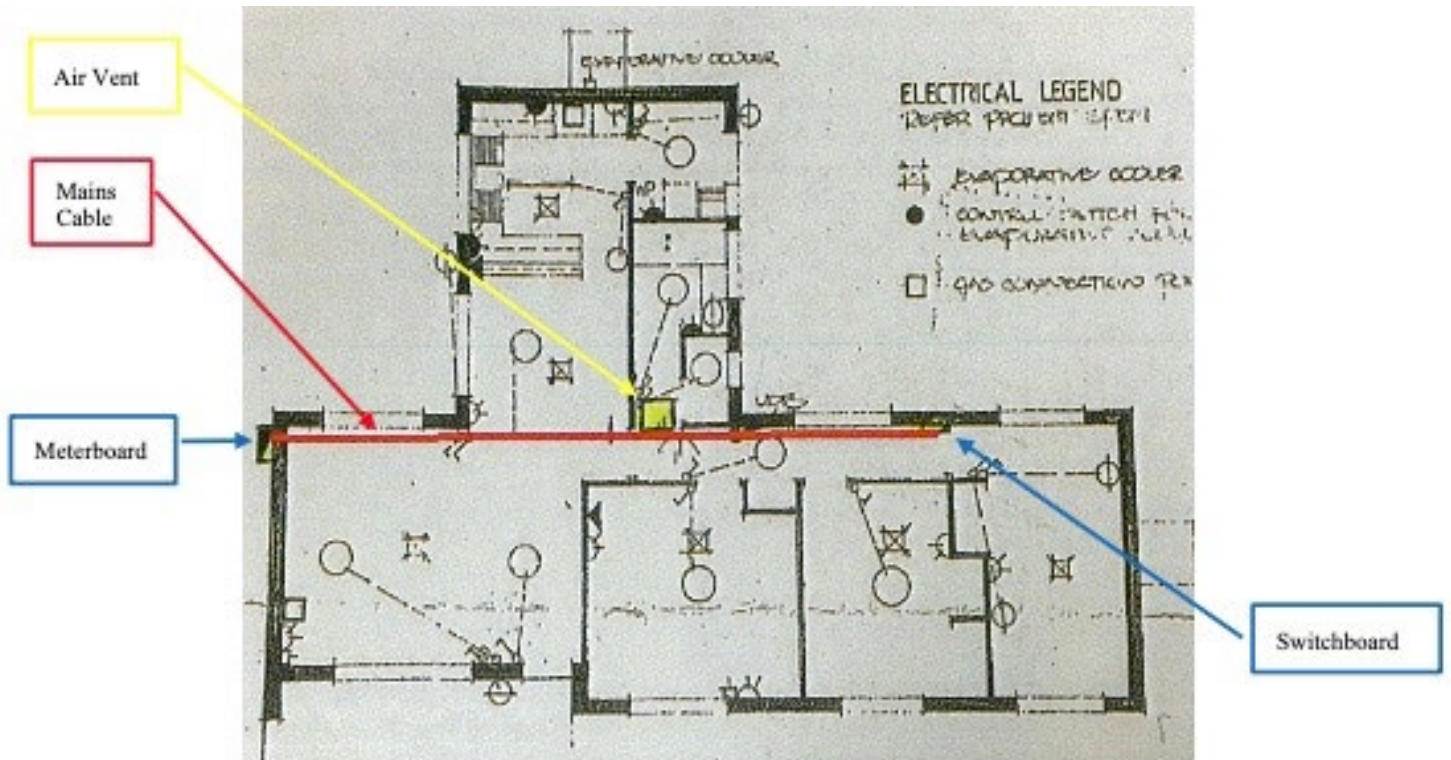
Figure 2

37. A twin core cable and another cable were providing power and switching to the light in the toilet and to the light and fan in the bathroom respectively. Mr Swift found these cables wrapped around the mains supply cable.

- a. The fire was caused by electrical arcing in the roof space of the home adjacent to the Air Vent.
- b. The electrical arcing began because of degradation of the insulation around two adjacent wires.
- c. It was not possible to determine whether the degradation of the insulation had been caused by mechanical damage, chemical damage, environmental damage or by the action of rodents, though rodent damage is widespread and common.⁶⁴
