CITATION: *Inquest into the death of Peter John Bonnell*  
[2018] NTLC 002

**CATCHWORDS:** **Collision by motorcycle rider with temporary traffic control devices, rider impairment, failure to install traffic control devices in accordance with Australian Standard, report to DPP**

**PETER JOHN BONNELL**  
**ON 30 APRIL 2016**  
**AT TIGER BRENNAN DRIVE**

**FINDINGS**

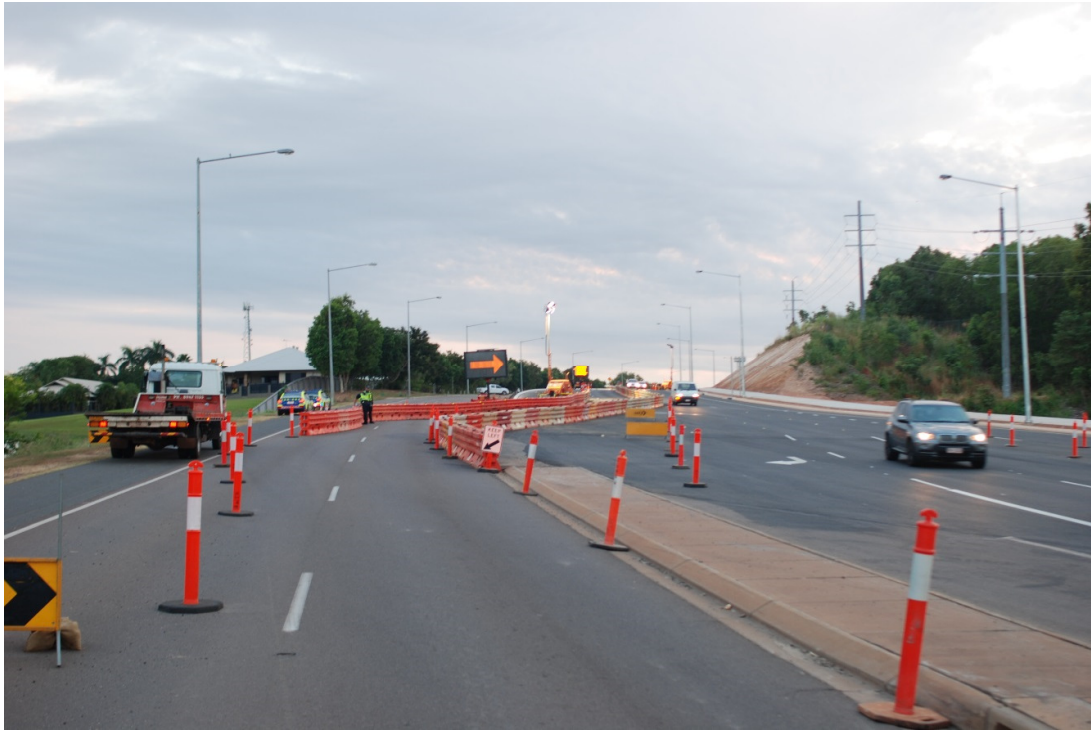
21. He said the barriers used to delineate the curve had no retroreflectivity and were not designed to be used at night time to delineate a curve. In the approach to the crossover, a white broken line travelled straight into the non-reflective barrier. That appears to be the path that the deceased travelled.

23. Not doing so, was non-compliant with AS1742.3 clause 3.9.4(b):

“If existing markings are not appropriate or are potentially misleading, they should be removed and replaced by more suitable markings ...”

26. The following picture taken just after dawn on the morning of the crash shows the direction of the white line into the barriers.

“It [the white line] should have been rubbed out or blacked out and retroreflectivity stickers or cat’s eyes ... used to create a delineation for the line work or repaint it so that it was available for delineation.”<sup>2</sup>

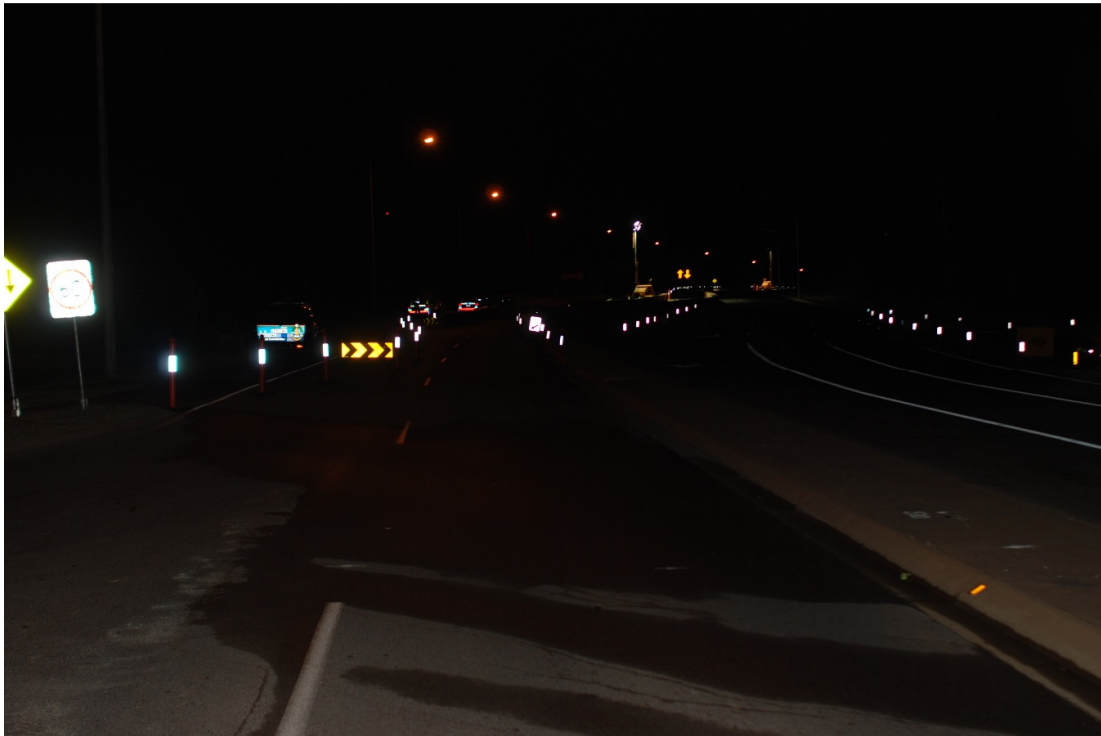
27. The following picture was taken on the night Mr Bonnell crashed into the barrier.

“The above photograph was taken on the night of the incident, while it is poor quality and not a true representation of available ambient light or headlight illumination, it does highlight the deficiency of retroreflective delineation at the start of the right curve formed by the lateral shift crossover.”

29. He said there should have been reflective bollards on each side of the road inside the barriers. The approved Traffic Control Diagram (TCD) had retroreflective bollards on each side for the whole of the crossover. Without those the setup could not be compliant with AS1742.3 clause 4.14.6(d):

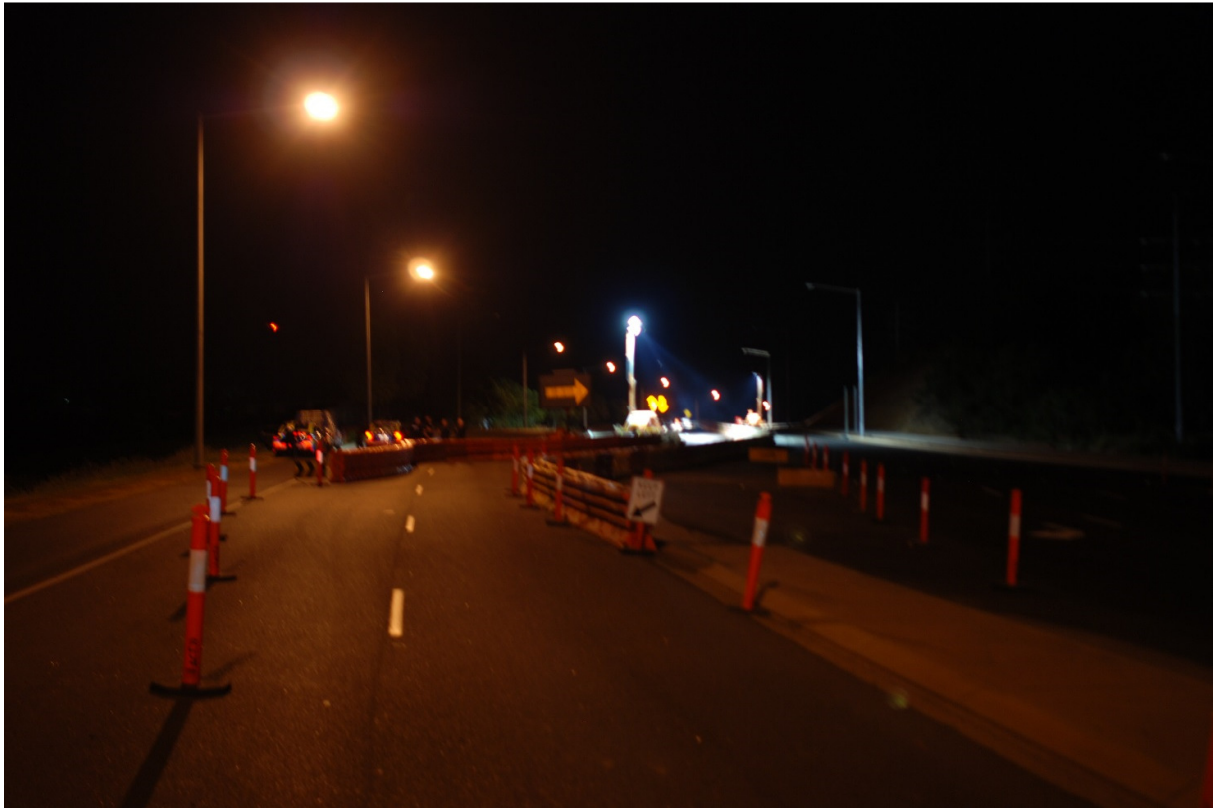
30. He noted also that the flashing illuminated arrow was not aligned to the approach to the curve.

“The above time exposure photograph provides a more realistic view of the lighting conditions present at the time of the incident, with the

trailer-mounted flashing directional arrow now visible, although it is misaligned with the approaching travel lane and may be camouflaged to some degree against the lighting plant background glare”

33. It is likely the side of the barriers facing Mr Bonnell as he approached the crossover were in relative shadow due to the glare of the lighting plant.

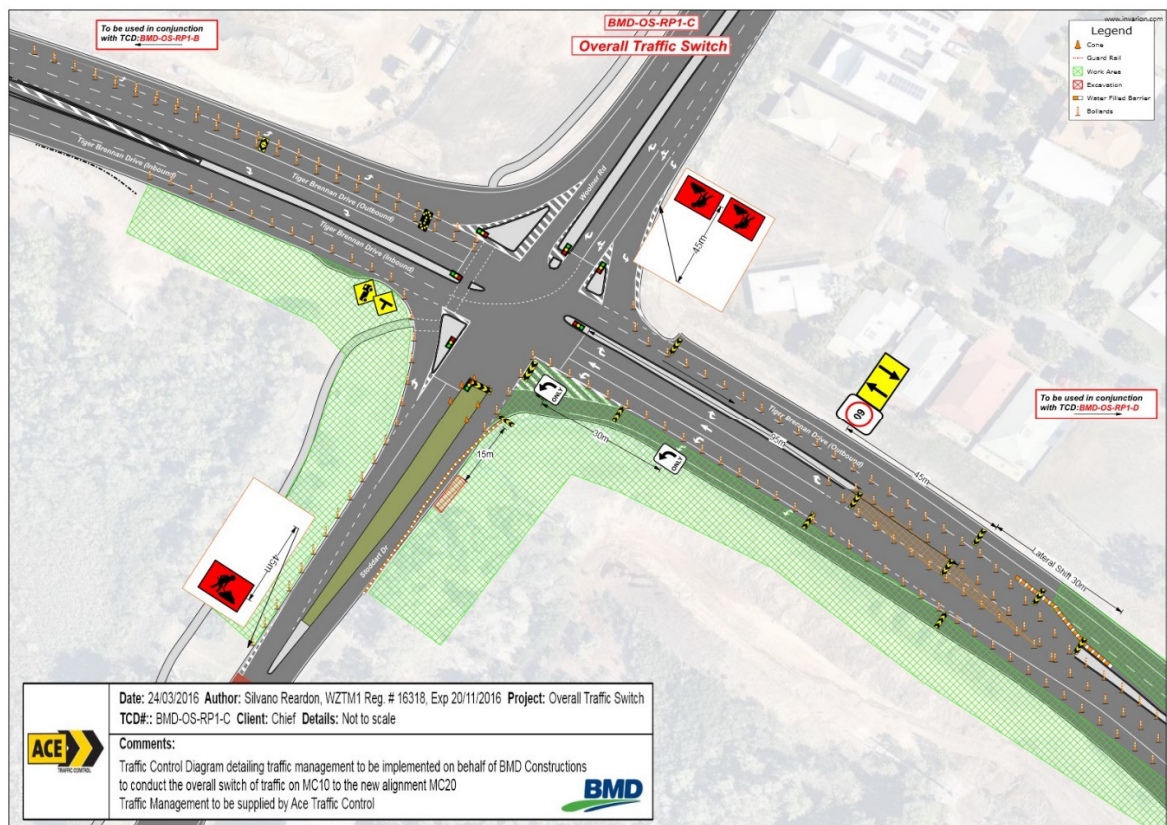
Diagram 1 showing approved TCD for Woolmer Road intersection with retroreflective bollards delineating the intended path of the traffic at commencement of crossover (right lower part of diagram)

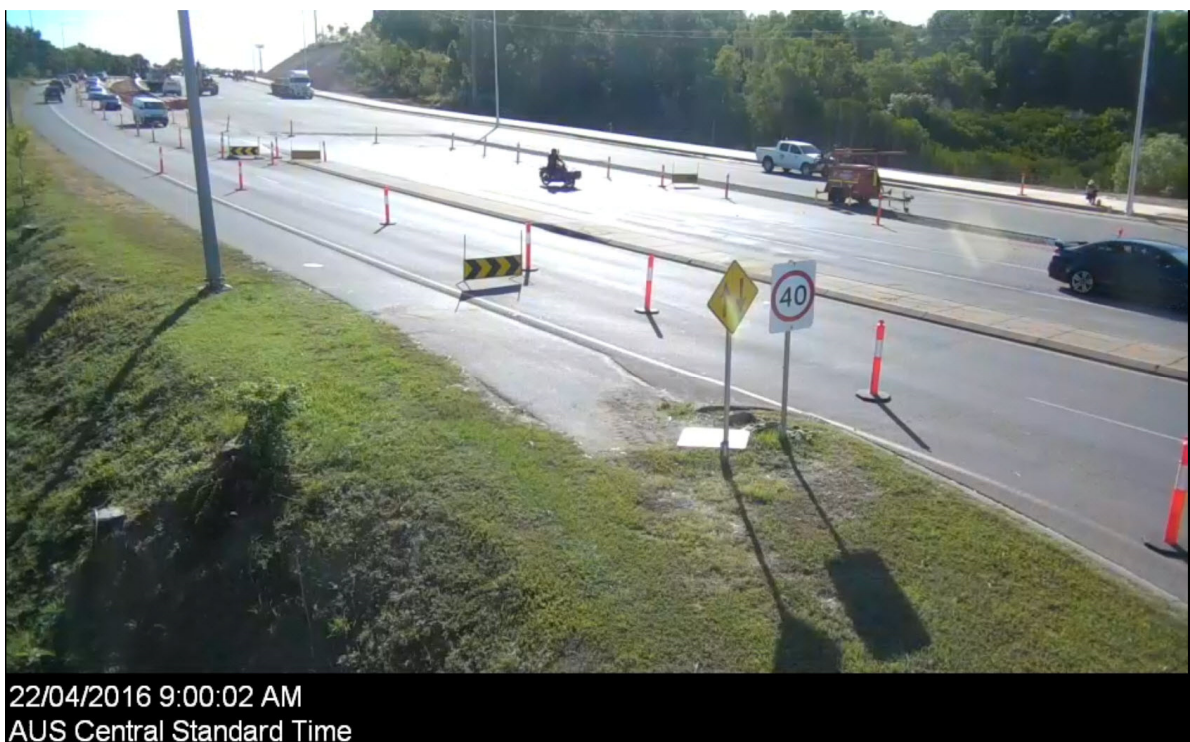
73. Looking outbound from the Woolner Road intersection before the Switch was set up, traffic control was as depicted in the photograph below.

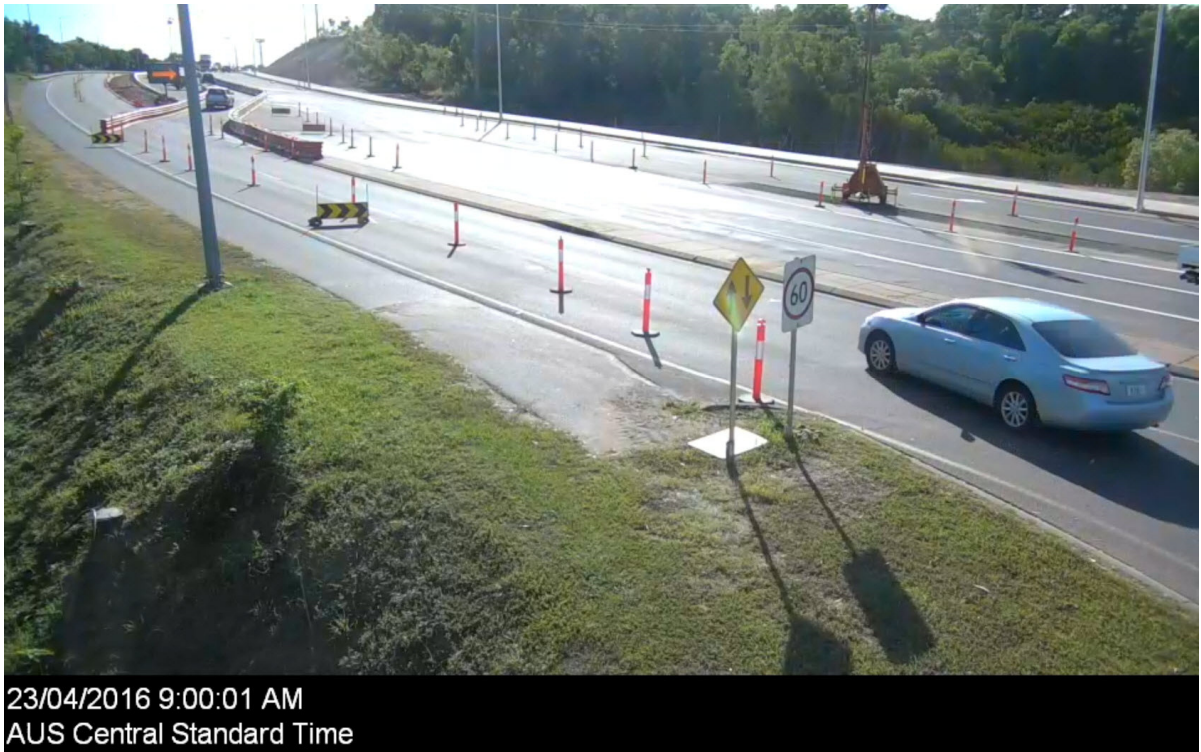
74. The next morning it had been changed as depicted in the following photograph.

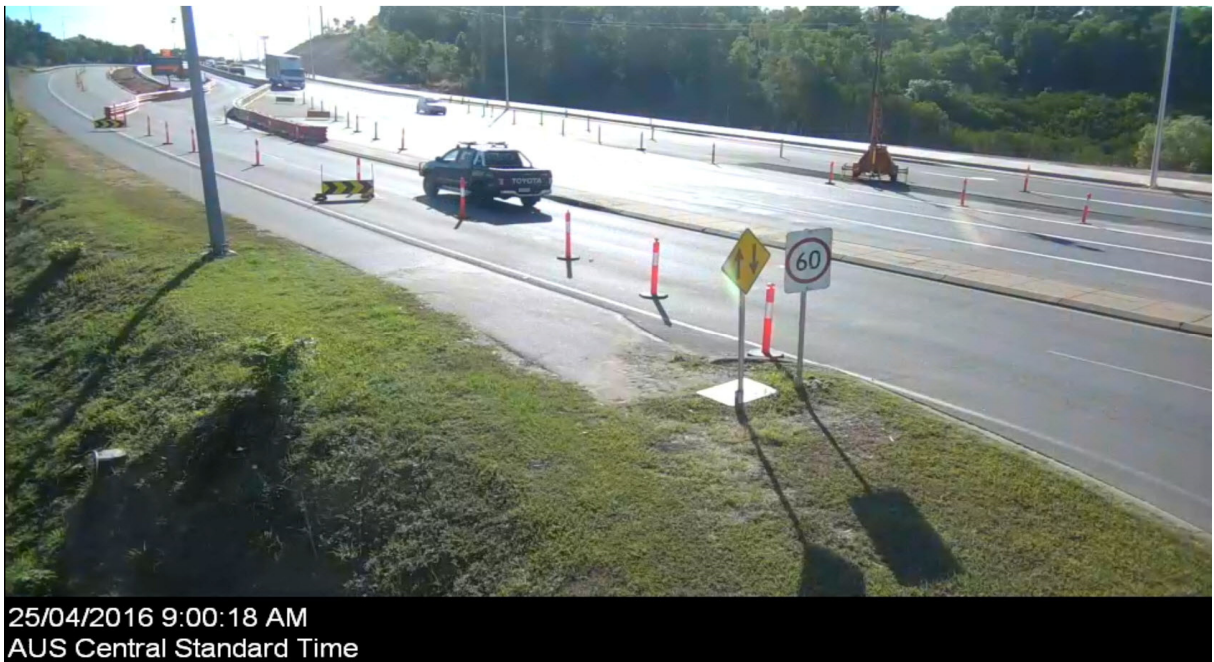
On the morning of 25 April 2016 the view showed that some of the interlocking barriers on the left had been moved out of alignment.

76. It is not known how that happened. The movement of the barriers was not known to BMD or DIPL and there appears to be no record of that being noticed during any inspection and audit. It is however likely that the movement occurred due to the barrier being hit by a vehicle.
77. Four days later correction was made. There is no note of who put the barriers back into alignment. DIPL and BMD said they had no knowledge of that either.

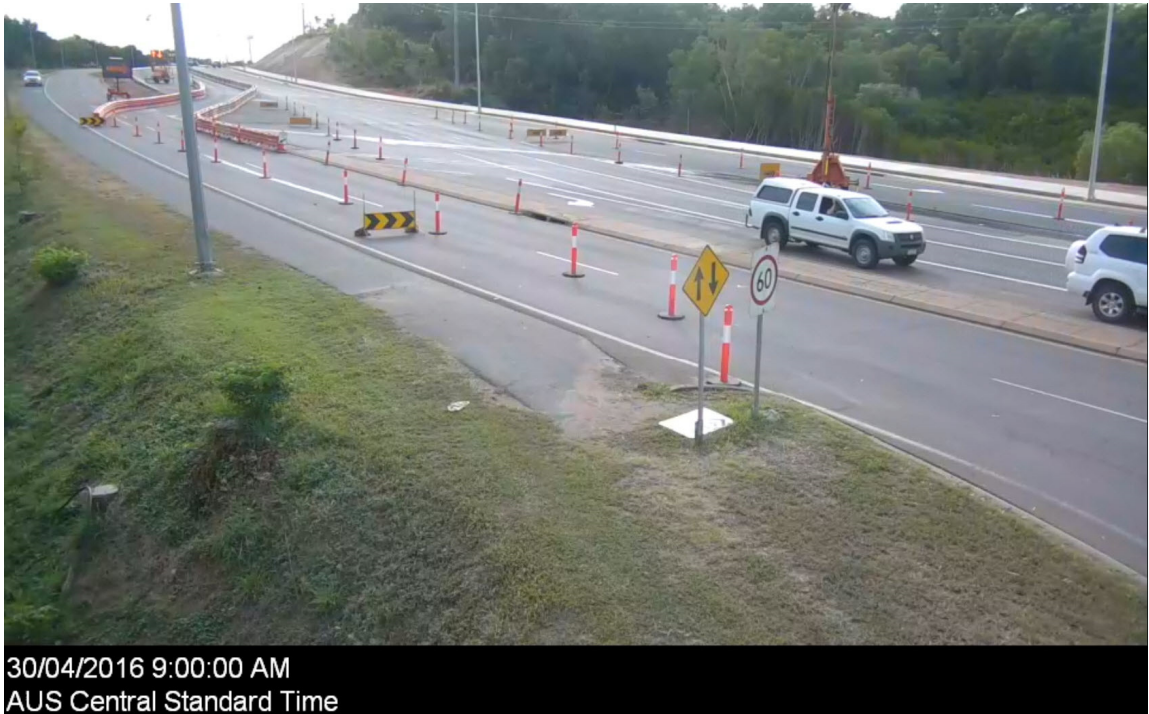
78. After the deceased struck the barriers they were pushed out of alignment again, as depicted in the photograph below.

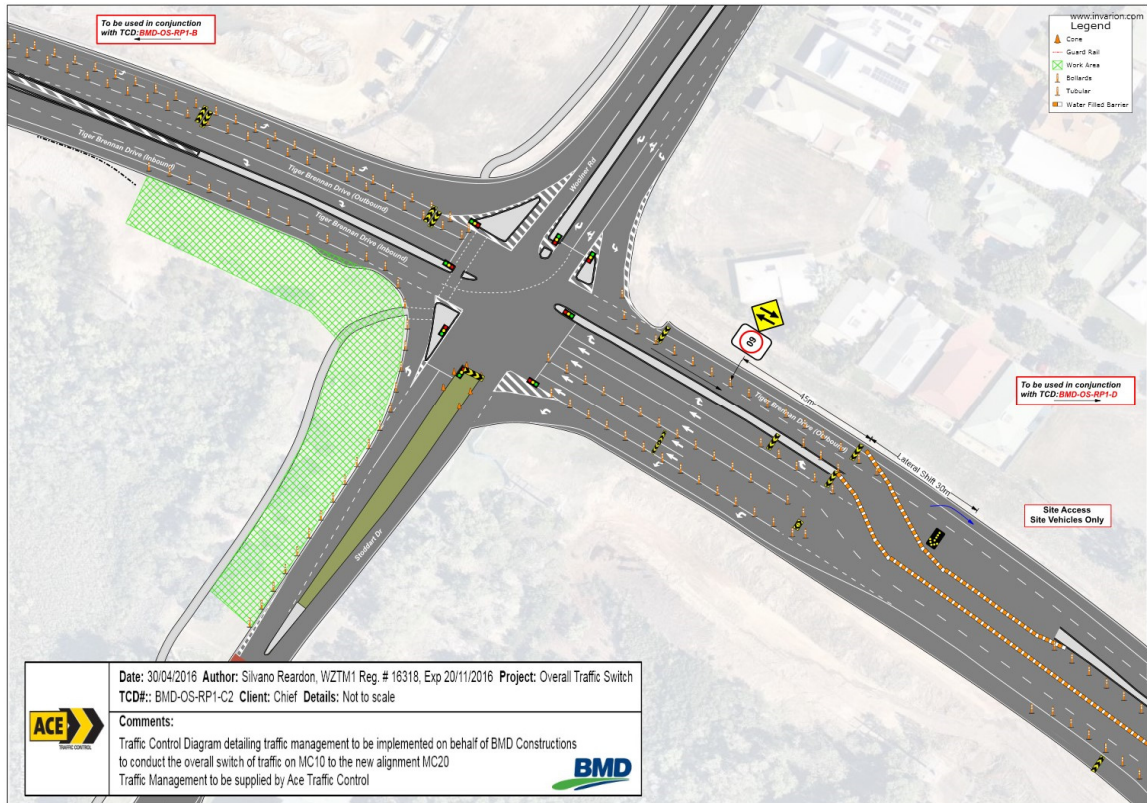
79. On the day of Mr Bonnell's death (30 April 2016), Ace Traffic Control was asked to prepare a TCD reflecting the actual setup of the Switch at the Woolner Road Intersection. They did so.

Diagram 2 showing TCD prepared on 30 April 2016 illustrating actual setup

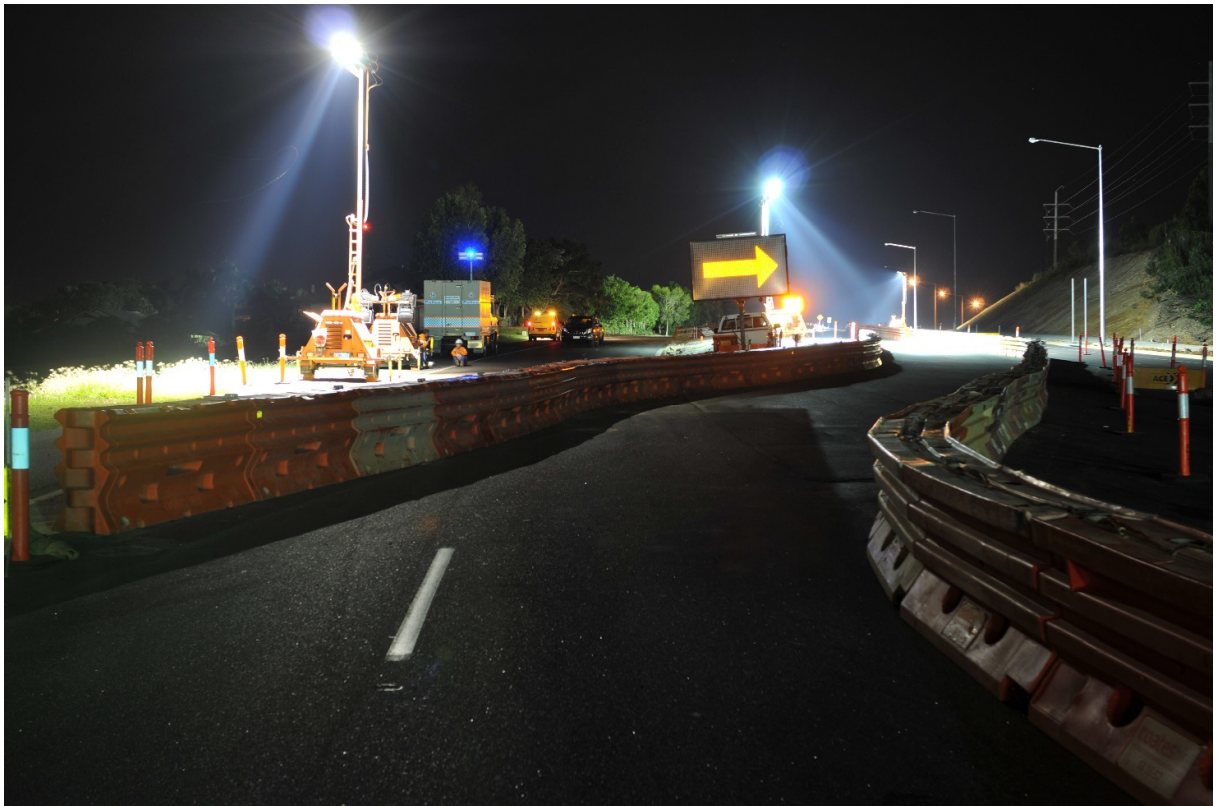
Photo 8 showing reflectors on barriers (taken a week later)

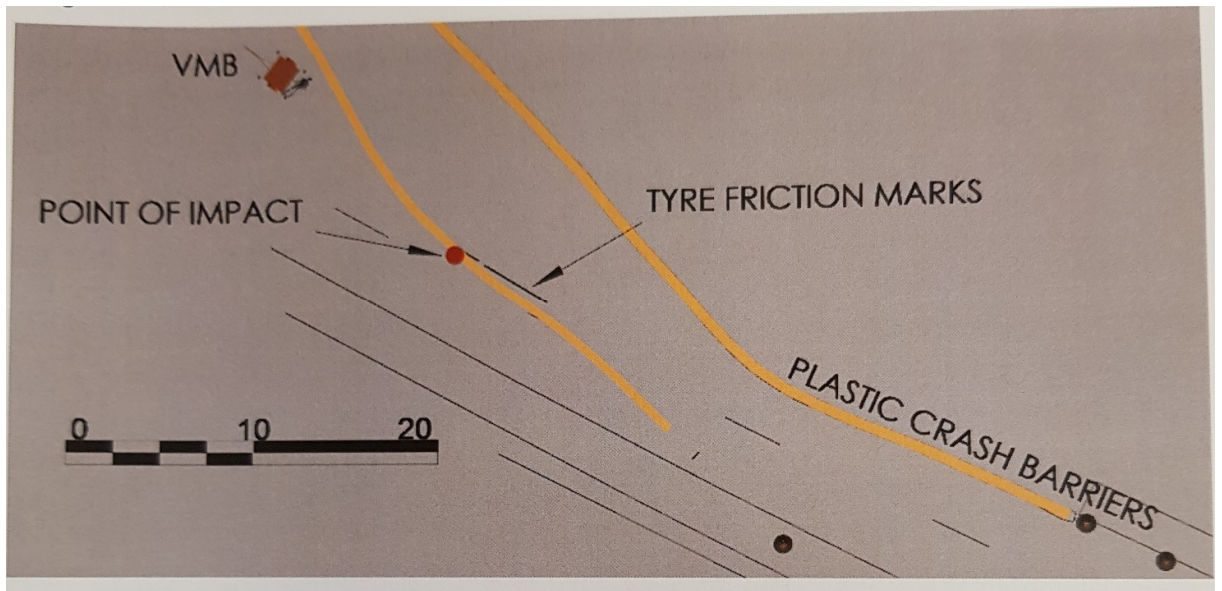
Diagram 3 showing the crash barriers before impact as well as tyre friction marks, position of the VMB (illuminated flashing arrow on trailer) and position where the deceased was located after impact

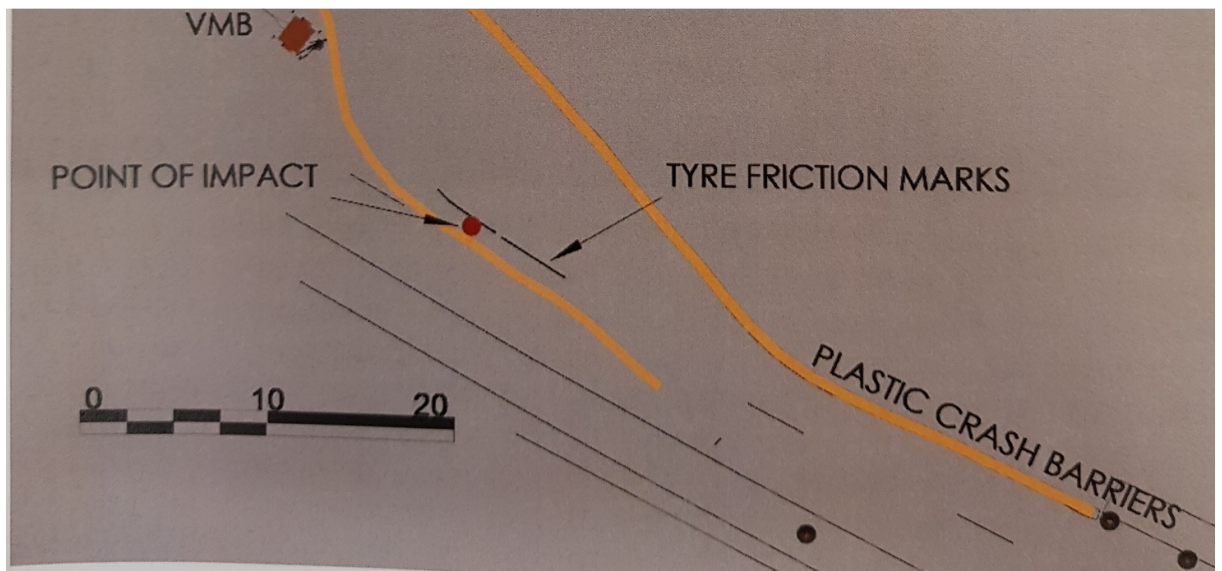
Diagram 4 showing the crash barriers after impact as well as tyre friction marks, position of the VMB (illuminated flashing arrow on trailer) and position where the deceased was located
