IN THE CORONERS' COURT OF THE NORTHERN TERRITORY

CORONERS' FINDINGS

I, Elisabeth Armitage, Coroner, have investigated the death of **TWO MEN** whose deaths occurred on 28 March 2024, at Arnhem Highway, Kakadu in the Northern Territory. **These are road deaths 16 and 17 of 2024.**

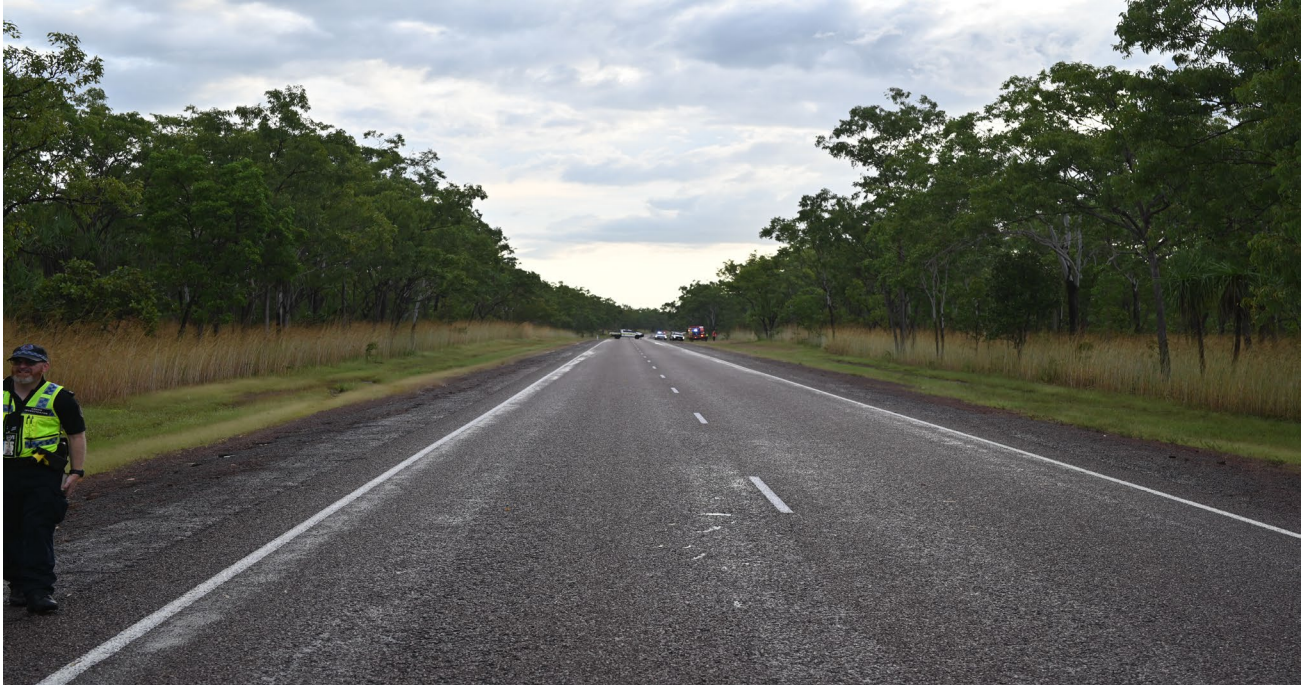
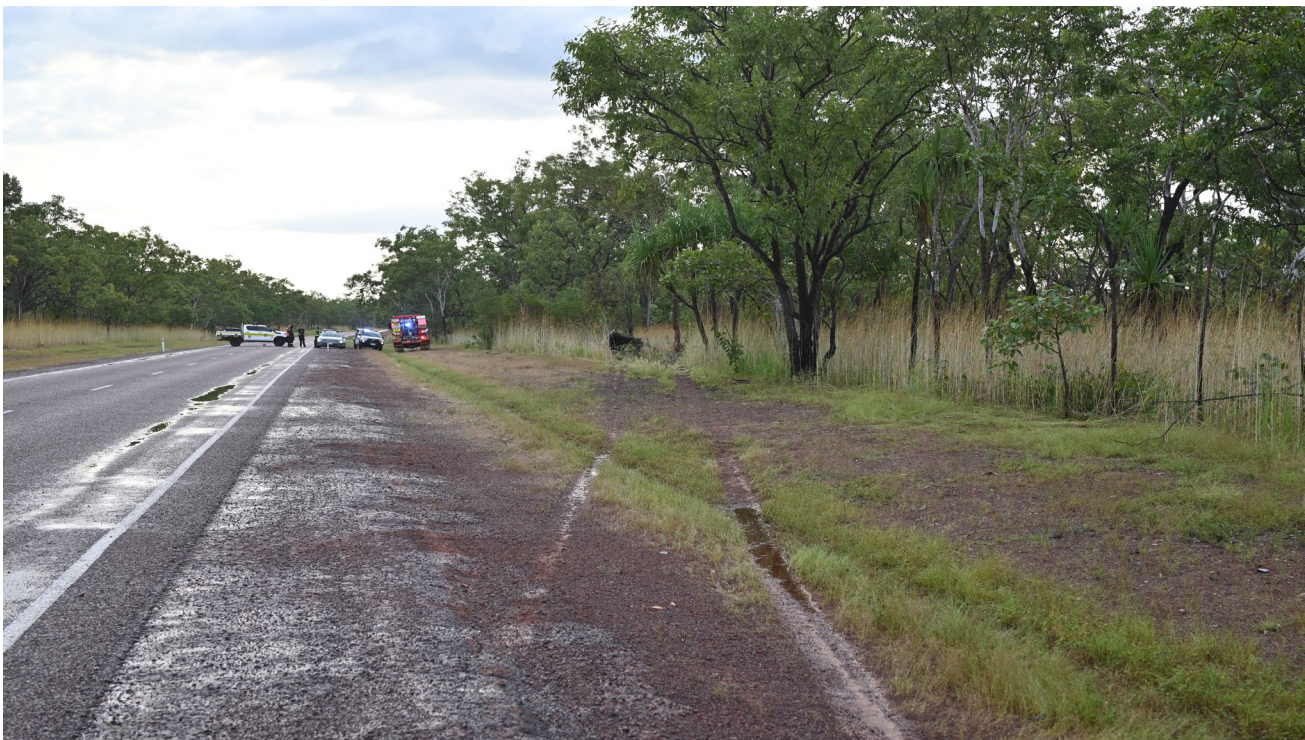
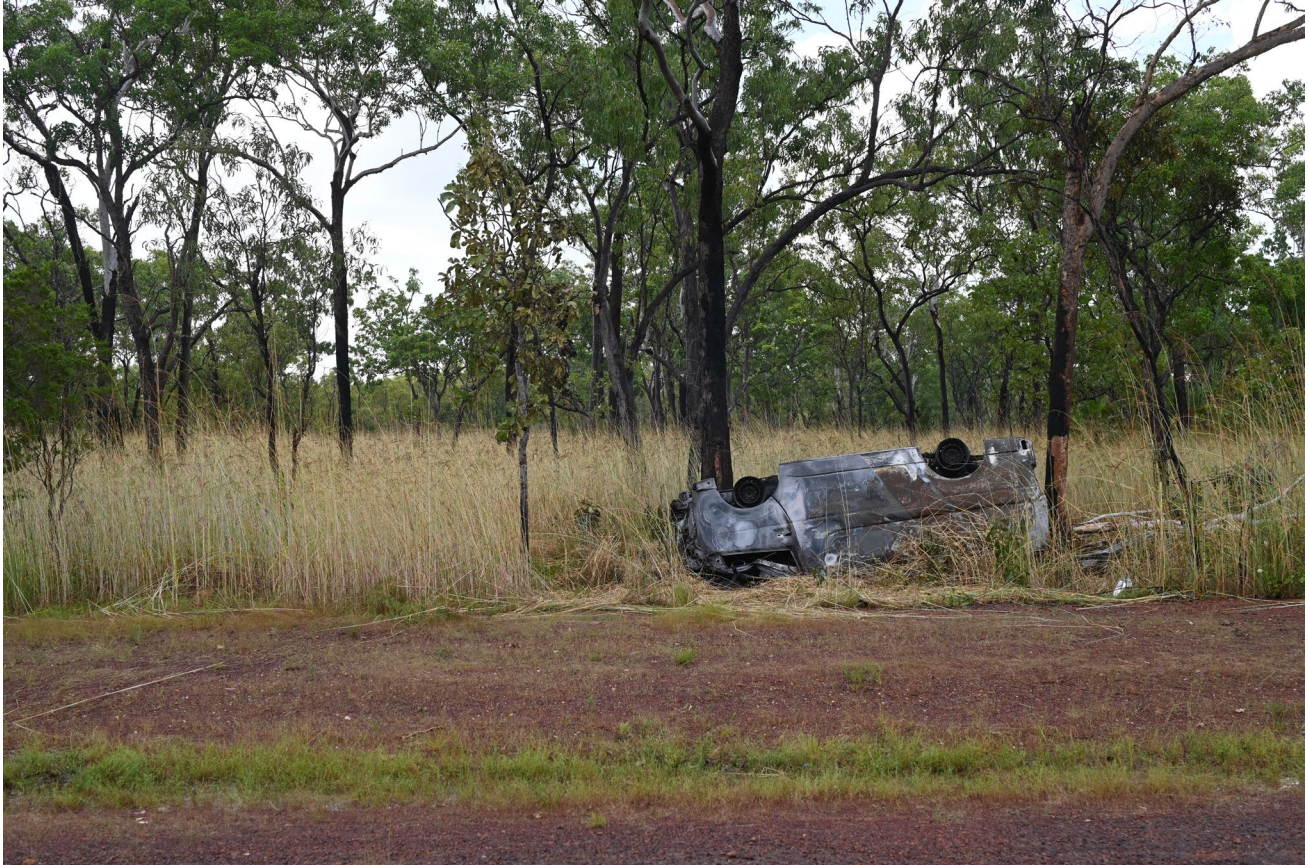
Selected photographs courtesy Major Crash investigations

- For an unknown reason the van has left the road at speed. The surviving passenger reported a possible tyre blow out, however, there was no scene evidence to support this theory. No tyre fragments were located relevant to the crash and no scuff marks or gouges were identified on the road surface.
