CITATION: *Inquest into the death of Daniel Thomas Bradshaw*  
[2018] NTLC 005

**CATCHWORDS:** **Death of deckhand, dangerous access  
and egress from vessel, no gangway,  
regulatory response to death**

In the matter of an Inquest into the death of  
**DANIEL THOMAS BRADSHAW**  
**ON 8 JANUARY 2017**  
**AT BARGE EXPRESS**  
**25 MURAMATS ROAD, HUDSON CREEK**

**FINDINGS**

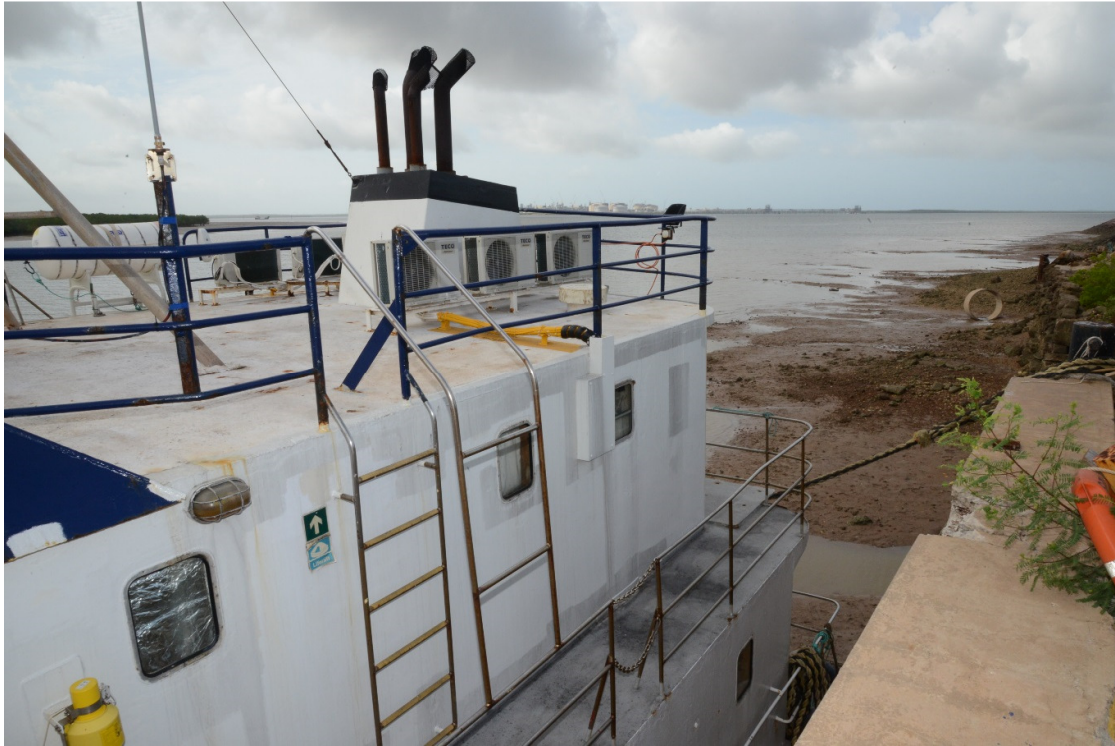
Photo 1 Showing the railing and ladder used for support while stepping from the barge to the wall.

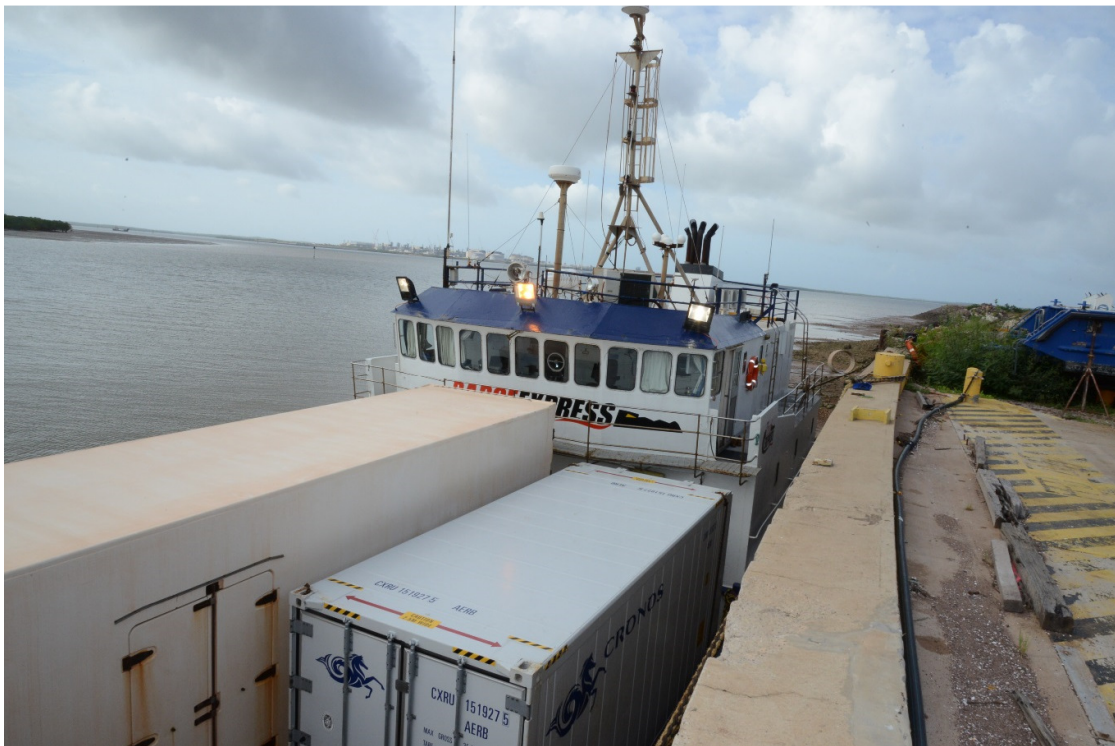
Photo 2 showing the railing and ladder in the distance.

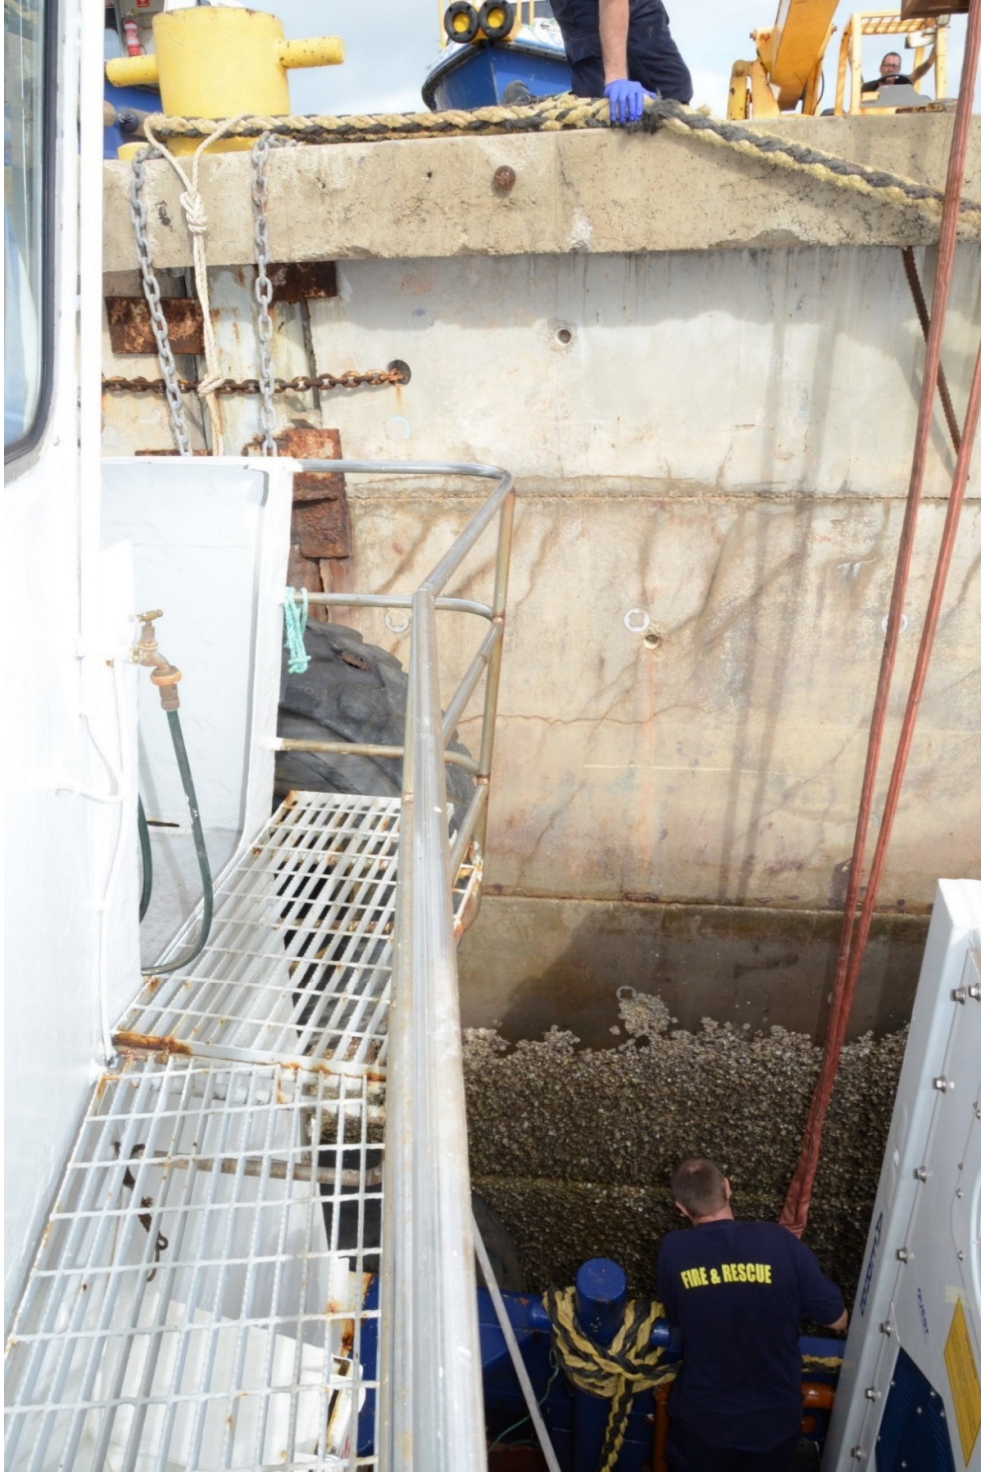
15. As the tide dropped however, that was not able to be done, and access and egress were gained by stepping onto a tyre on the wall and using the chains that held the tyre to get up and onto the wall.

Photo 3 showing the bridge wing, tyre and chains and the distance to the top of the wall

16. No one on the boat considered it necessary to put in place a gangway. That was despite the Safety Management Manual stating:

“When the ship is safely alongside, a gangway must be rigged in order to secure safe access to the ship. The gangway must be rigged with rail, safety net and appropriate lighting.”

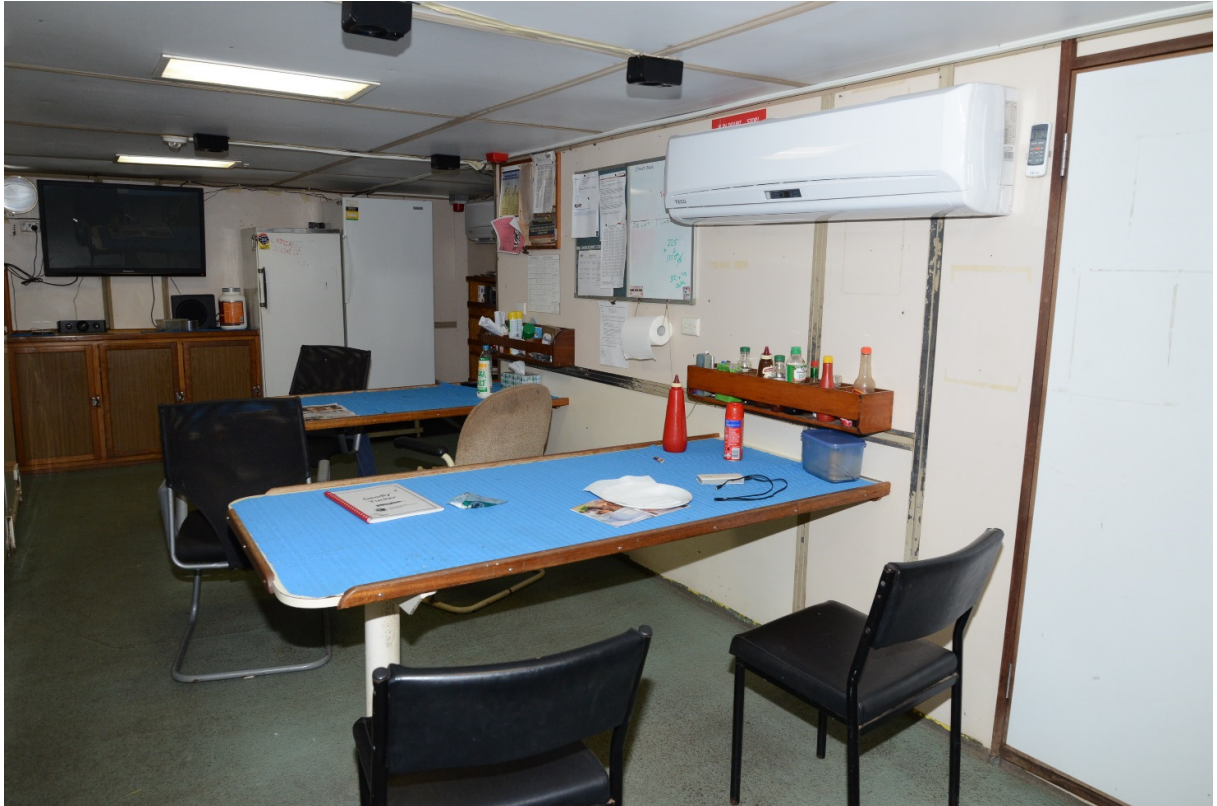
Photo 4 of galley showing plate at position where Dan sat and portable phone charger and cord

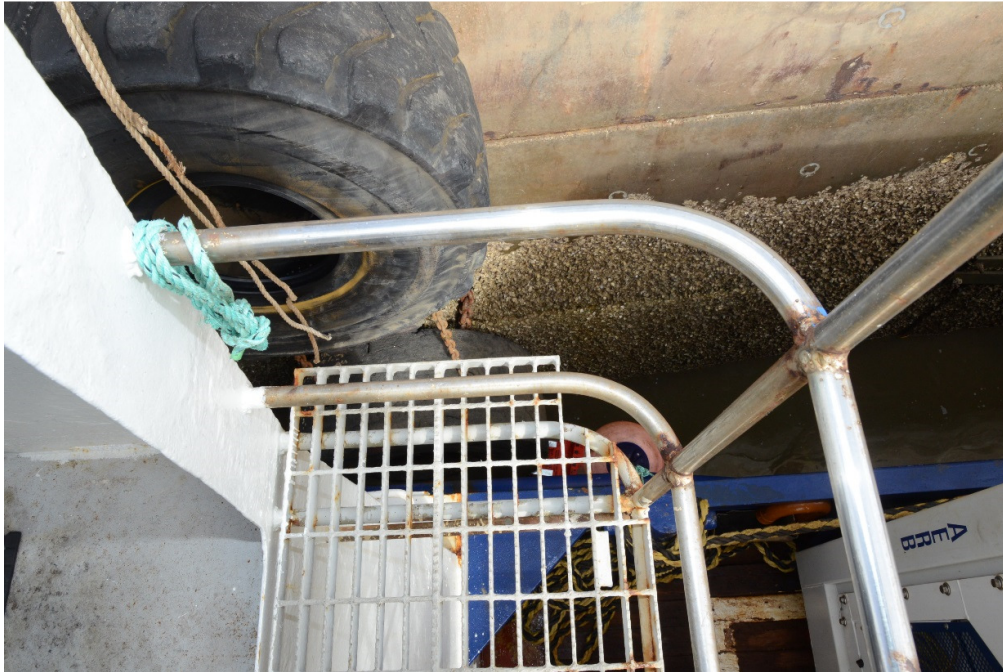
32. The laceration to the back of his head was in the opinion of Dr Rutherford due to a sharp edge rather than blunt trauma. The laceration travelled in an upward manner through the flesh to the skull.

33. The only sharp edge proximate to the location of his body likely to have been responsible for the laceration was the edge of the grated tread on the bridge wing.

Photo 5 showing edge of protruding bridge wing

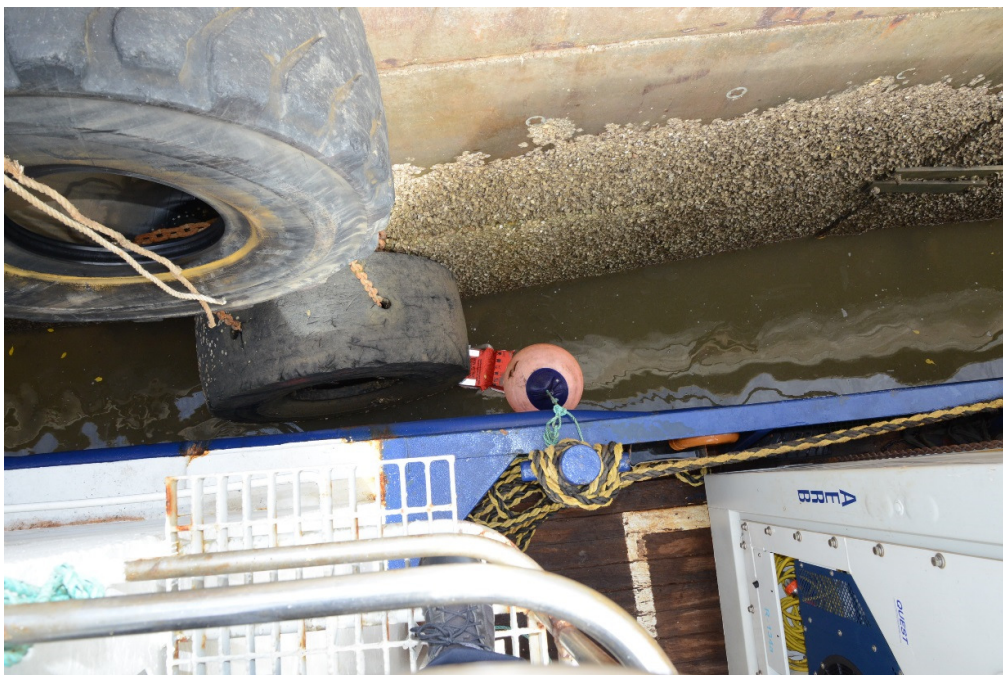
34. Below were the hard (albeit rounded) surfaces of the gunwales.

Photo 6 showing gunwale below bridge wing

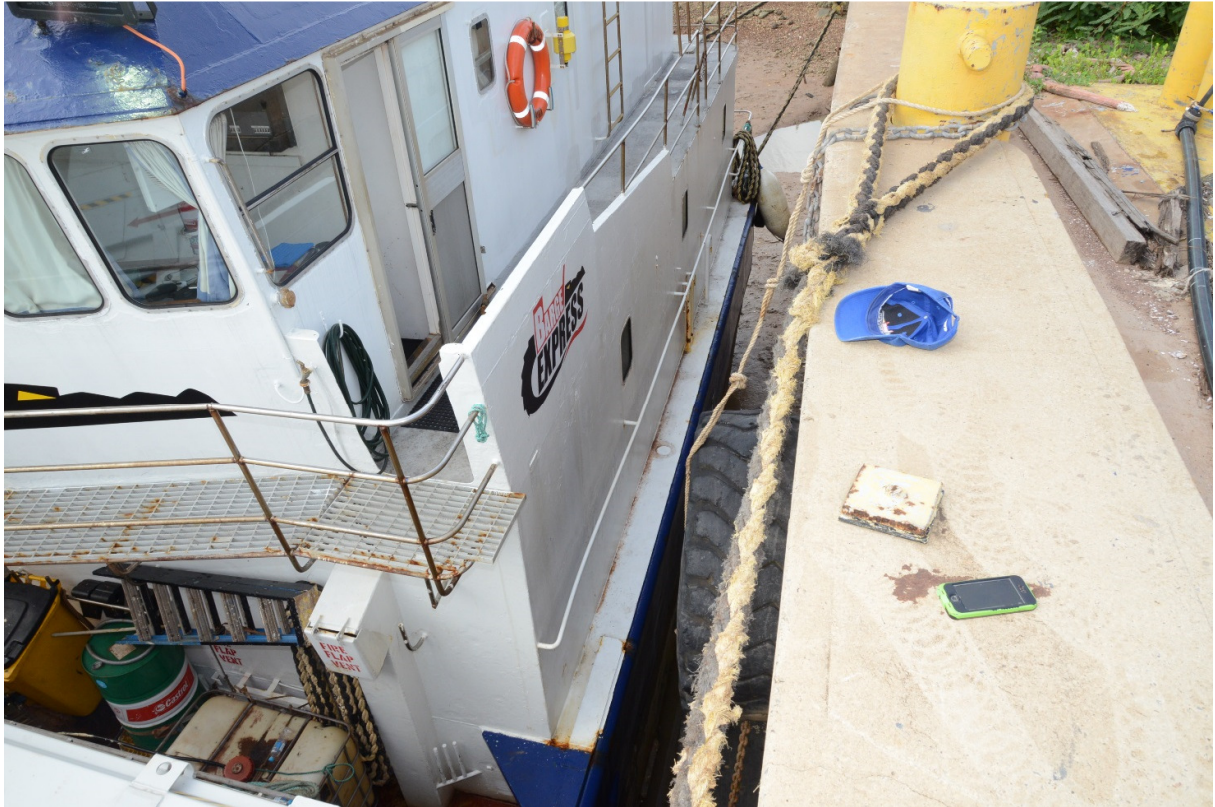
35. On the top of the Wall were Dan's mobile phone and cap.

Photo 7 showing Dan's cap and mobile phone on the top of the wall (the stain under the phone is rust and the tile nearby is fixed).

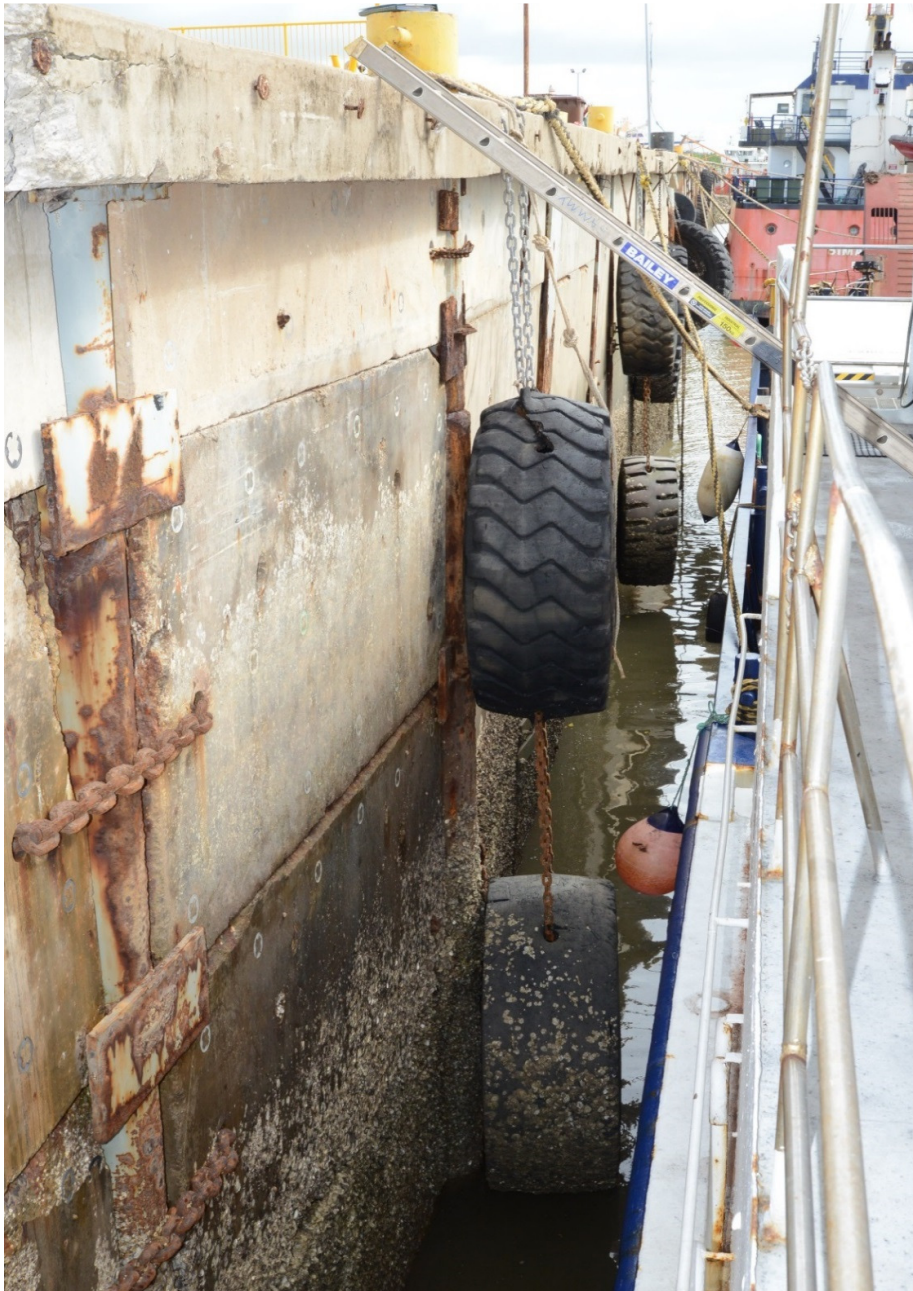
Photo 8 - Exhibit 5 depicting the means of access (minus the ladder)

67. The ladder in the photograph was put in that position after the death to allow access for the police officers undertaking the forensic analysis on the vessel. Why no gangway was used is likely because there was no suitable gangway.

68. I asked both the manager of Barge Express and Mr Hemming whether what that photo depicted was a safe means of access. They both agreed that it was not.

**Coroner:** Well, not only is that method shown by that photograph unsafe, surely it's dangerous as well isn't it?
