IN THE CORONERS' COURT OF THE NORTHERN TERRITORY

CORONERS' FINDINGS ROAD DEATH 14 OF 2024

Section 34 of the Coroners Act 1993

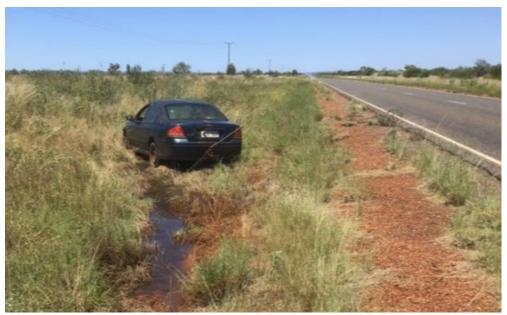
As the vehicle approached the area of Gilbert Swamp, approximately 5km north of the Epenarra turnoff, the driver pulled the vehicle hard to the left. The vehicle entered the spoon drain, becoming bogged.

Photo courtesy of the police investigation

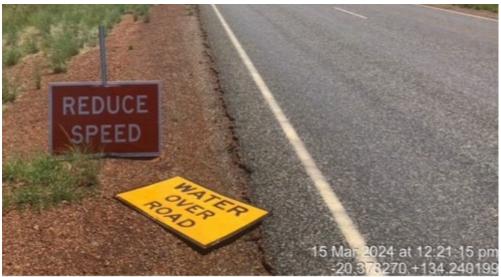
The group alighted the vehicle and attempted to push it from the bog with no luck. One male located a "reduce speed" road sign and attempted to flag down passing motorists, with no success.

Photo courtesy of the police investigation

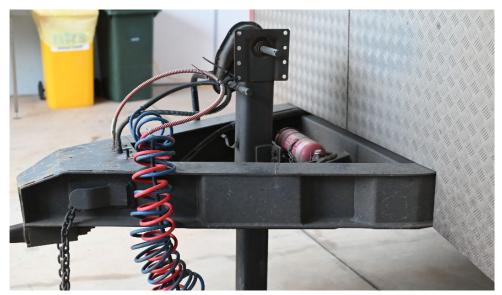
Without the knowledge of Greyhound staff, the deceased, holding his bottle of rum, climbed on to the drawbar of the trailer to hitch a ride.

Photo of the tow bar courtesy of the police investigation

A mechanical inspection was not carried out on the coach, and deemed not necessary, due to the mode of death. The trailer was forensically examined by the Northern Territory Police Forensic Services Unit. Results of the inspection confirmed the presumption of DNA belonging to the deceased on the trailer drawbar.
