CITATION: *Inquest into the death of Patrick Wayne Bloomfield*
[2021] NTLC 010

TITLE OF COURT: Coroners Court

In the matter of an Inquest into the death of

PATRICK WAYNE BLOOMFIELD

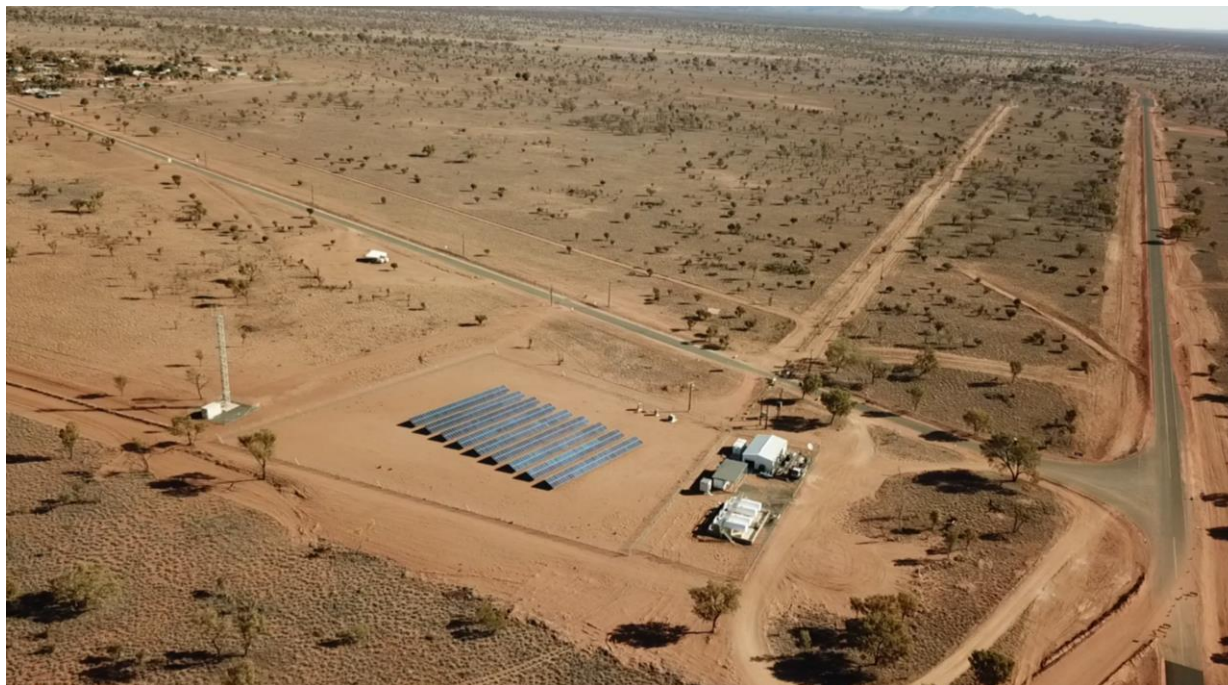
Photo 1: The Community of Atitjere can be seen in the top left hand. Mica Road runs diagonally toward the bottom right hand of the photo. The Plenty Highway is seen running down the right hand side of the photo. The commencement of the bypass can be seen just below the intersection.

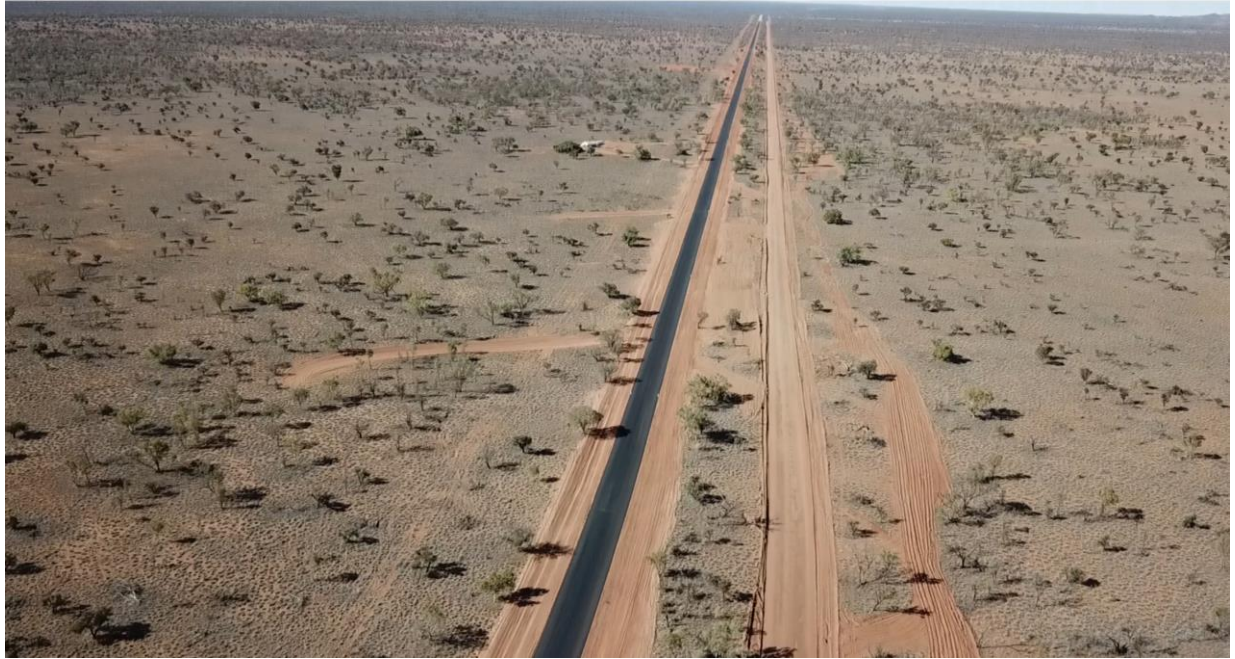
Photo 2: Heading east, the new bitumen on the plenty Highway and running parallel to it, the unsealed bypass road.

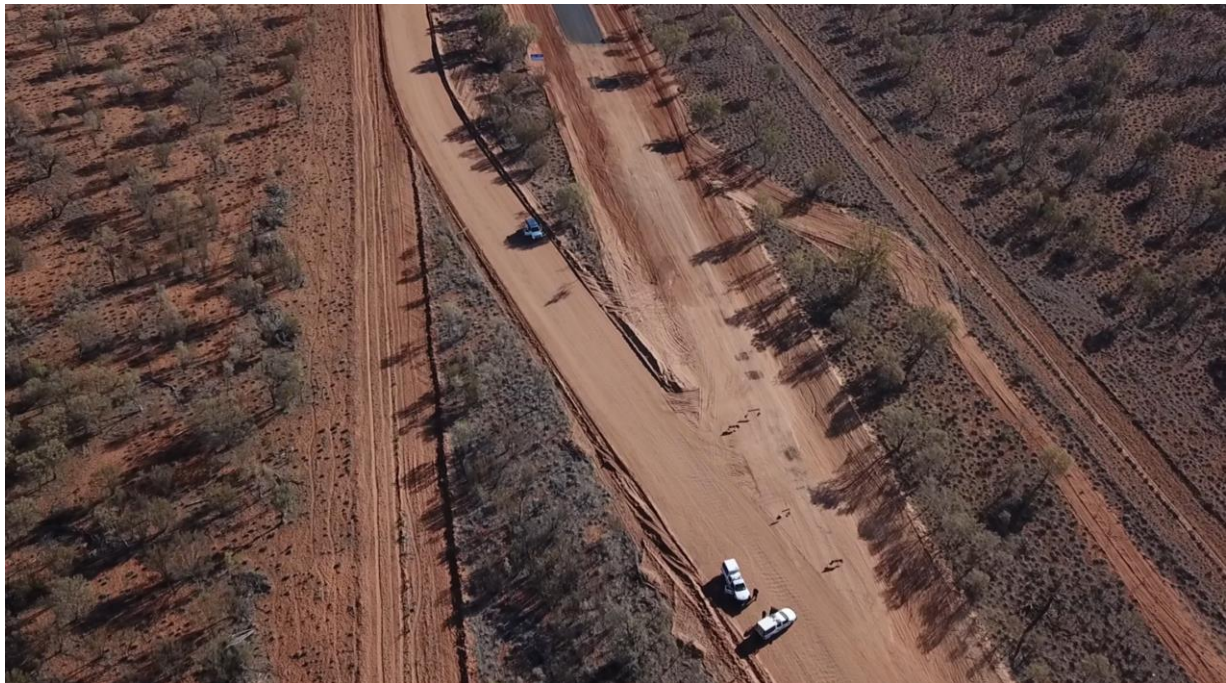
Photo 4: Bypass re-joining Plenty Highway. The Remote Sergeant was stationed at that end of the scene approximate to where the two vehicles are seen.

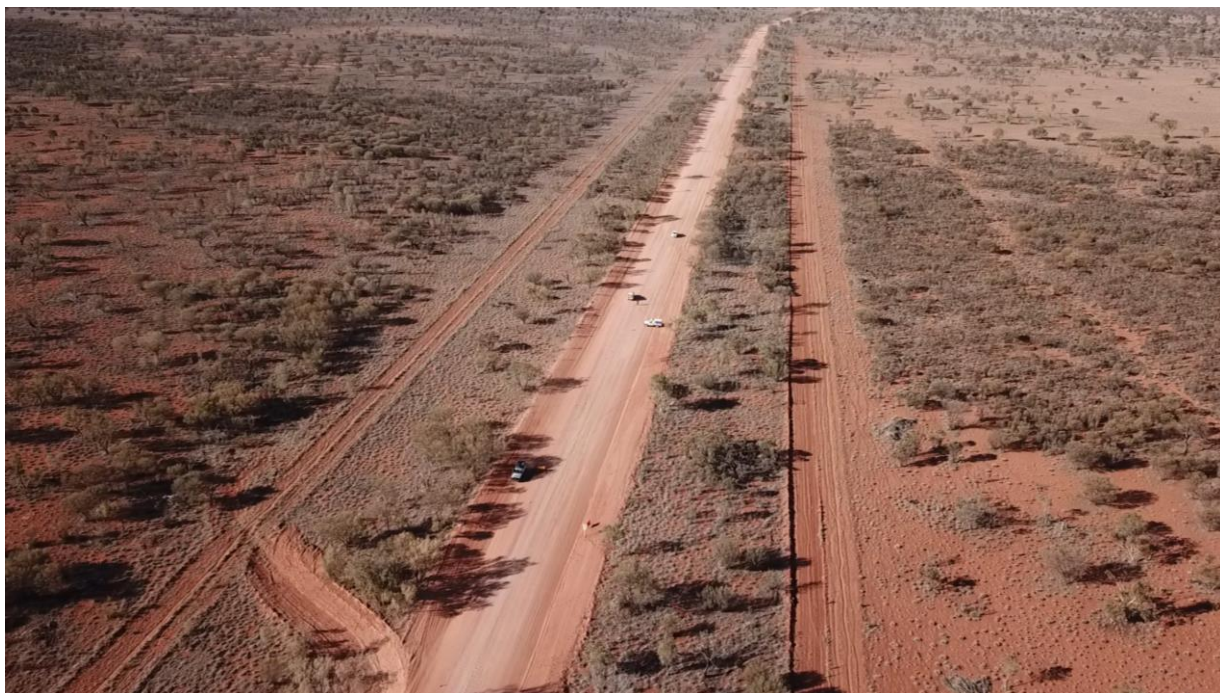
Photo 5: Looking down the Plenty Highway toward the scene of crash (approximate to white police vehicle parked horizontally and where the other officer stood guard at the scene).

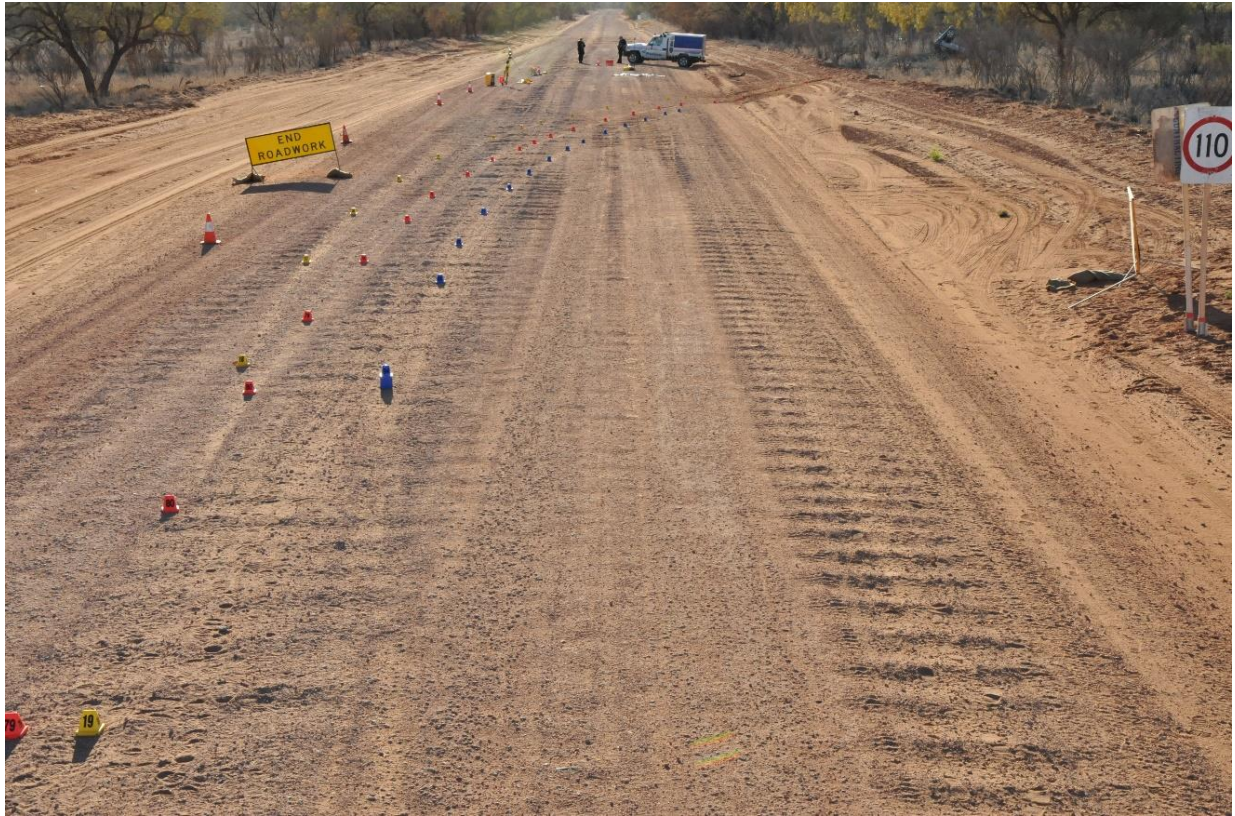
23. The following day the Major Crash unit marked out the tyre tracks of the Subaru. It is their opinion that the Subaru while travelling from the bypass onto the Plenty Highway at a speed of between 112 and 114 kilometres per hour went into a counter clockwise yaw, overcorrected and went into a clockwise yaw before tripping on the windrow at the side of the road and rolling.

Photo 6: Identification of tyre marks leading to wreckage.
