CITATION: *Inquest into the deaths of Robin Riley, Thomas Turpin, Fabian Andrews and Cassandra Martin* [2019] NTLC 23

CATCHWORDS: **Single vehicle rollover, Kakadu Highway, gravel on bitumen at intersection with unsealed road**

**AT: Kakadu Highway near the intersection
with Bukbukluk Road**

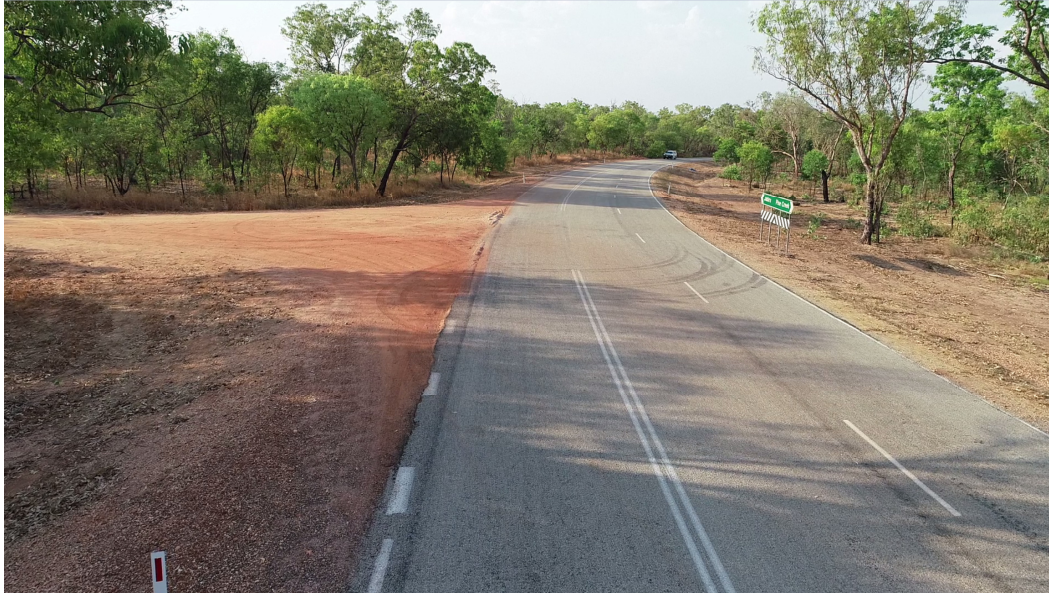
25. Seventy-six kilometres from the southern end is a turnoff to Bukbukluk Lookout where the crash occurred.

The intersection of Kakadu Highway and Bukbukluk Lookout Road (travelling north).

37. The second draft was provided to Police Investigators on 19 February 2019. It identified 1250 areas where improvements were recommended. It set out a risk assessment in relation to all substandard areas. In relation to the curve and intersection where the crash happened the auditors rated the risk at the highest category, “Intolerable” and recommended that the risk would be mitigated by putting a sealed apron on the Bukbukluk Road so that the gravel would not be deposited onto the Highway.

54. I recommend that the Department of Infrastructure, Planning and Logistics ensure that removing gravel from sealed surfaces is added to the schedule of maintenance items.
55. I recommend that the Department of Infrastructure, Planning and Logistics ensure that an apron is installed as soon as possible on the road to Bukbukluk Lookout to prevent gravel from being deposited on the Kakadu Highway.

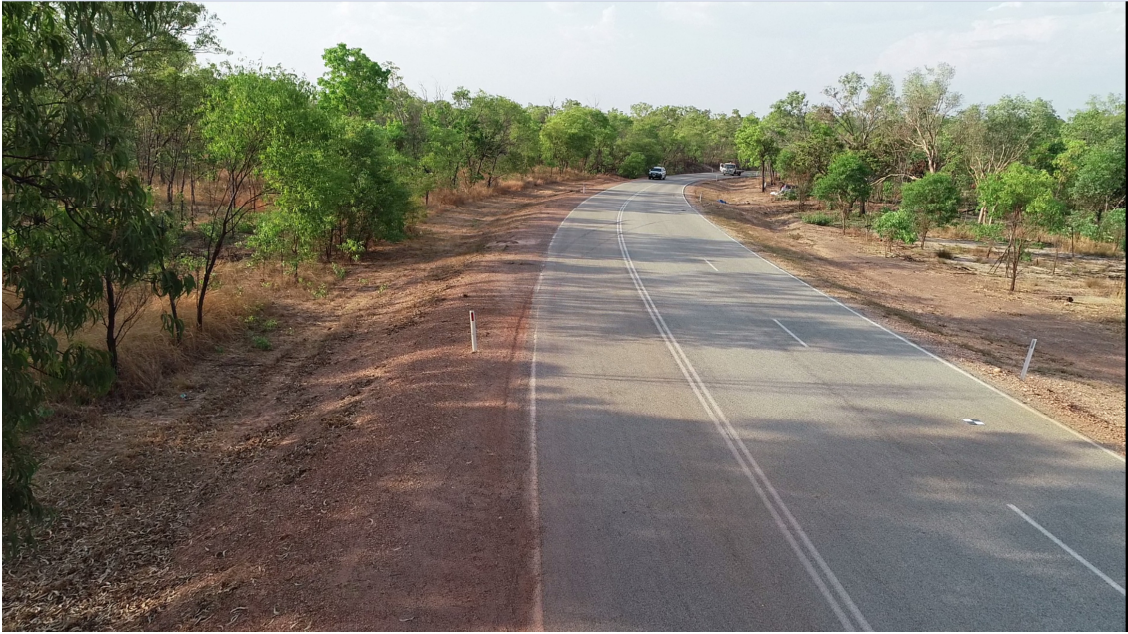
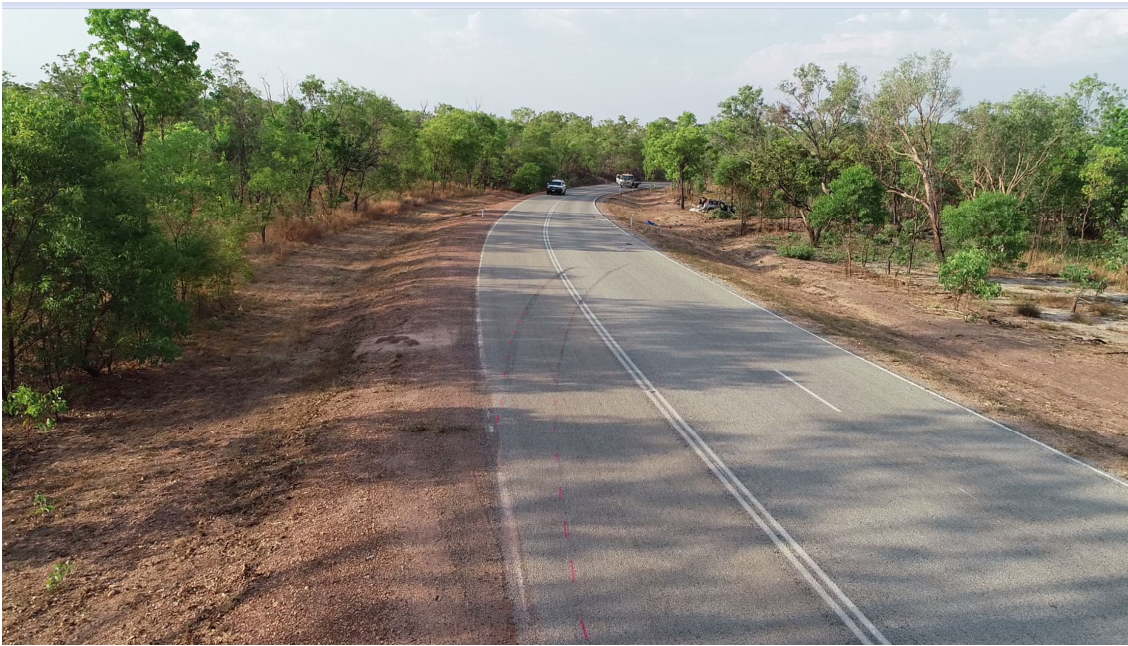
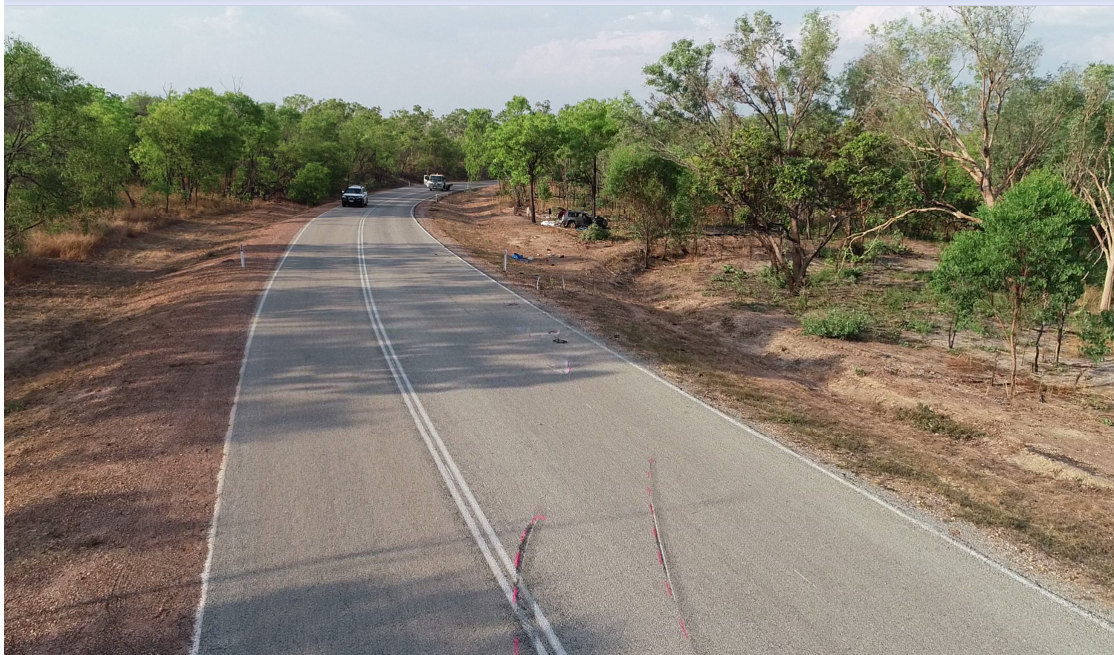
30. On the edge of the Highway surface at the intersection with the side road going to Bukbukluk Lookout gravel was deposited onto the Highway surface. Police calculated that the gravel on the road surface reduced the friction by about one third (0.690g to 0.432g).

31. In the opinion of the Major Crash Investigators, the curve was also a “substandard curve” meaning that if the Highway had been to Australian Standard 1742.2 it would have had an advisory speed of 90 kilometres per hour.

32. In approaching the curve Mr Riley did not take the optimal line. His outside wheels were close to the edge of the bitumen surface. In the opinion of the investigators the X-Trail vehicle began to slide while still on the bitumen surface. The left hand side wheels then left the sealed surface and travelled along the gravel shoulder until the vehicle went into a clockwise yaw and crossed the Highway before tripping while still on the bitumen and rolling.

33. The path of the vehicle as it went into the yaw and its final position can be seen in the following photographs.

44. During the inquest the Project Director, contrary to his earlier position, conceded that the gravel on the bitumen was one of the contributing causes of the crash. He indicated that the Department were hoping to commence a tender to put aprons on all such intersections on the Kakadu Highway. He hoped that the intersection where the crash occurred would have the sealed apron installed by the end of August 2019.
