CITATION: *Inquest into the death of Peter John Bonnell*  
[2018] NTLC 002

**CATCHWORDS:** **Collision by motorcycle rider with temporary traffic control devices, rider impairment, failure to install traffic control devices in accordance with Australian Standard, report to DPP**

**PETER JOHN BONNELL**  
**ON 30 APRIL 2016**  
**AT TIGER BRENNAN DRIVE**

**FINDINGS**

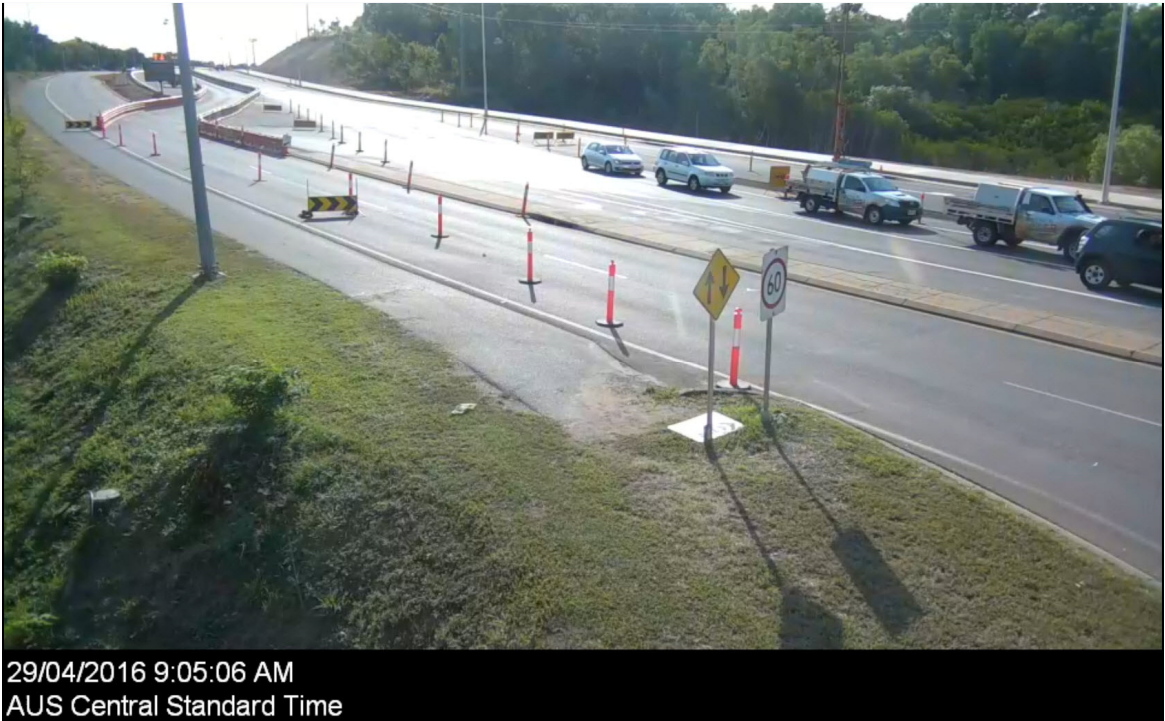
76. It is not known how that happened. The movement of the barriers was not known to BMD or DIPL and there appears to be no record of that being noticed during any inspection and audit. It is however likely that the movement occurred due to the barrier being hit by a vehicle.
77. Four days later correction was made. There is no note of who put the barriers back into alignment. DIPL and BMD said they had no knowledge of that either.
