IN THE CORONERS' COURT OF THE NORTHERN TERRITORY

**CORONERS' FINDINGS**  
**ROAD DEATH 29 OF 2024**

I, Elisabeth Armitage, Coroner, having investigated the death of a **65-YEAR-OLD CAUCASIAN MALE** and without holding an inquest, find that he was, born on **23 April 1959** and that his **death occurred on 22 June 2024, at Litchfield Park Road, Litchfield in the Northern Territory.**

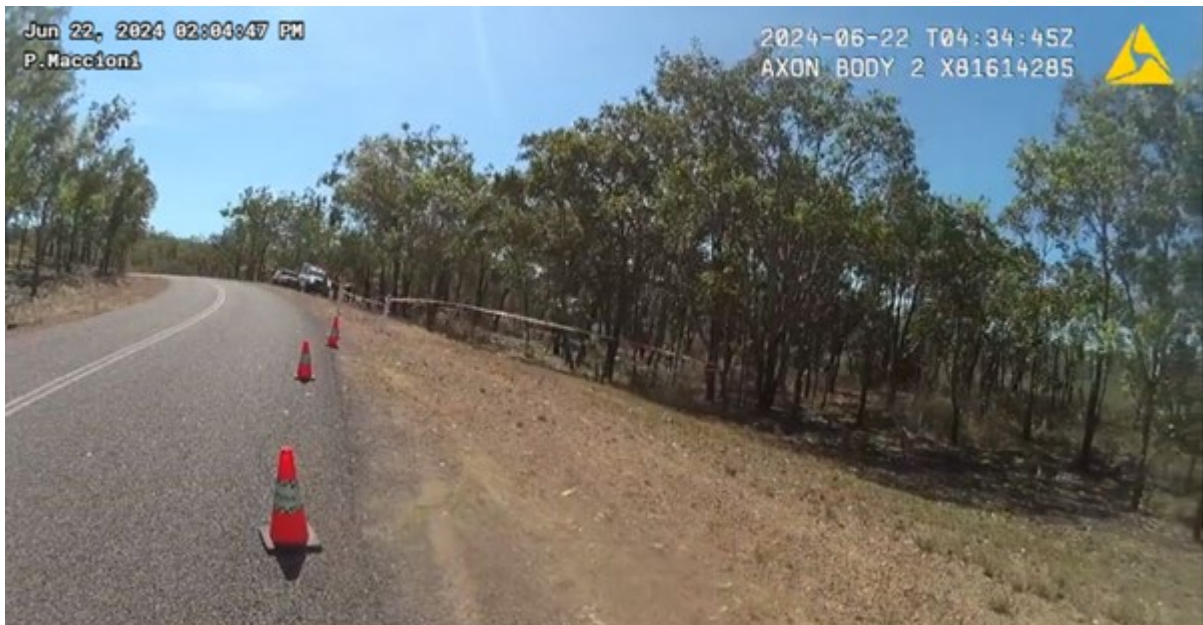
Looking towards the crash scene, to the right of the photo is the path the motorcycle travelled.

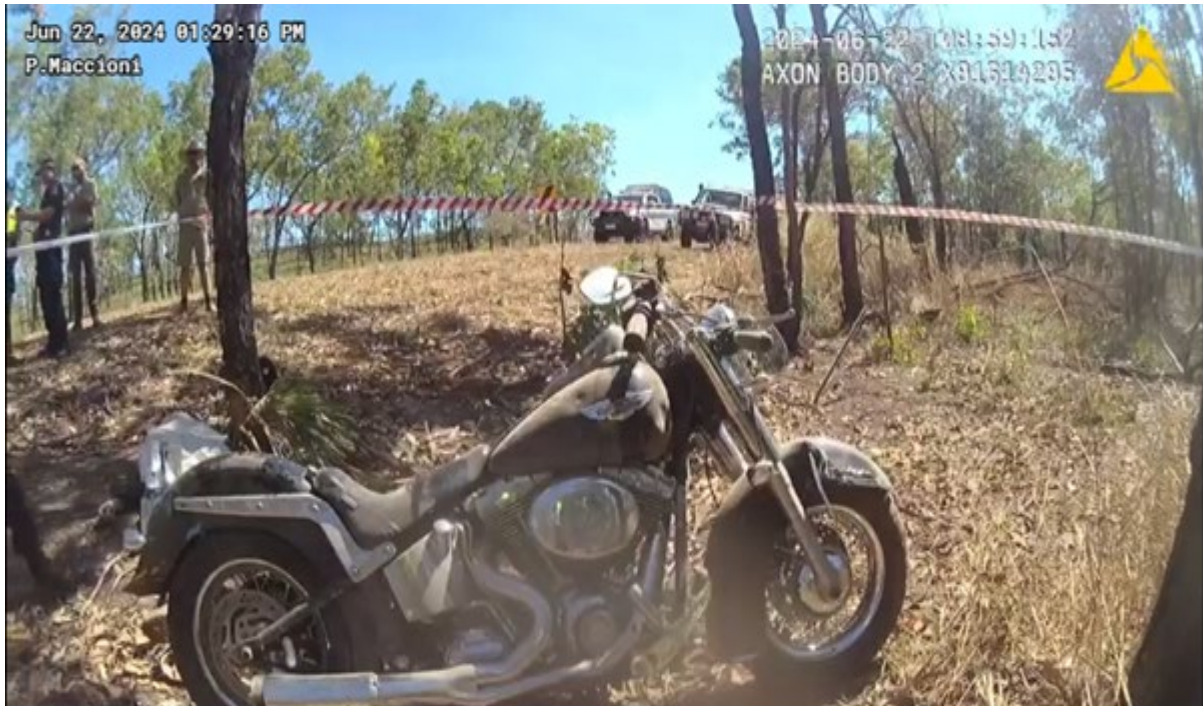
The motorcycle.

The motorcycle was visually inspected at the scene by a Senior Constable from the Traffic Unit. Its tyres were in good condition and inflated, and the braking system was functional. Overall, the motorcycle appeared to be kept in a well-maintained condition. It was not subjected to any further mechanical examination.

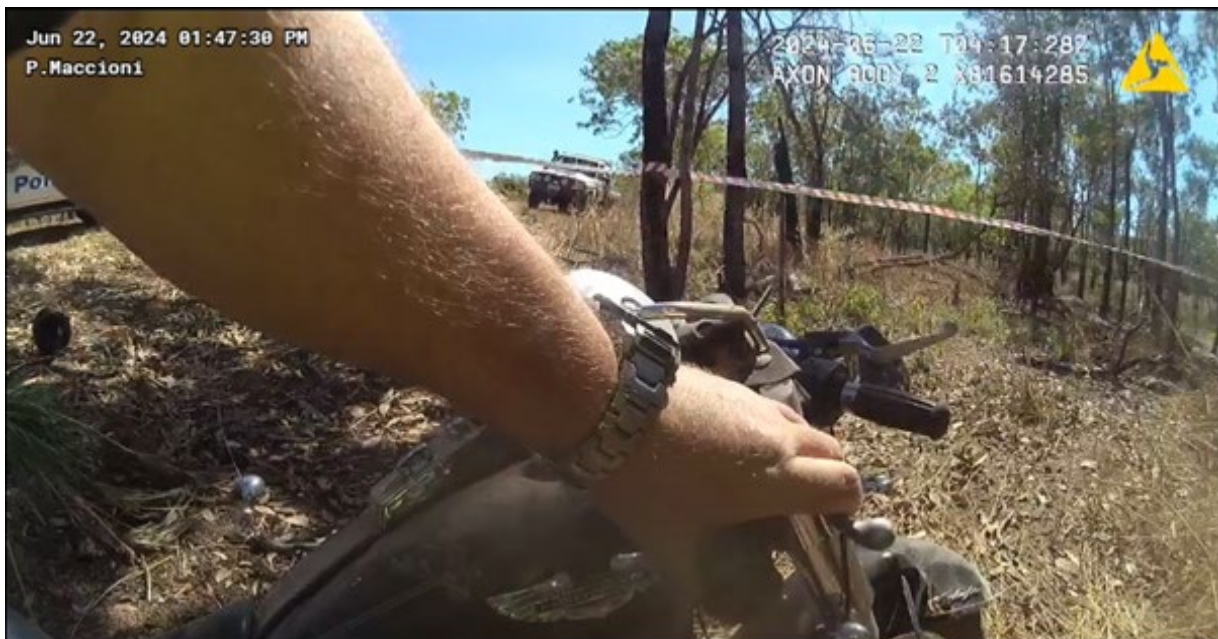
Senior Constable inspecting the braking system, which was in good working order.

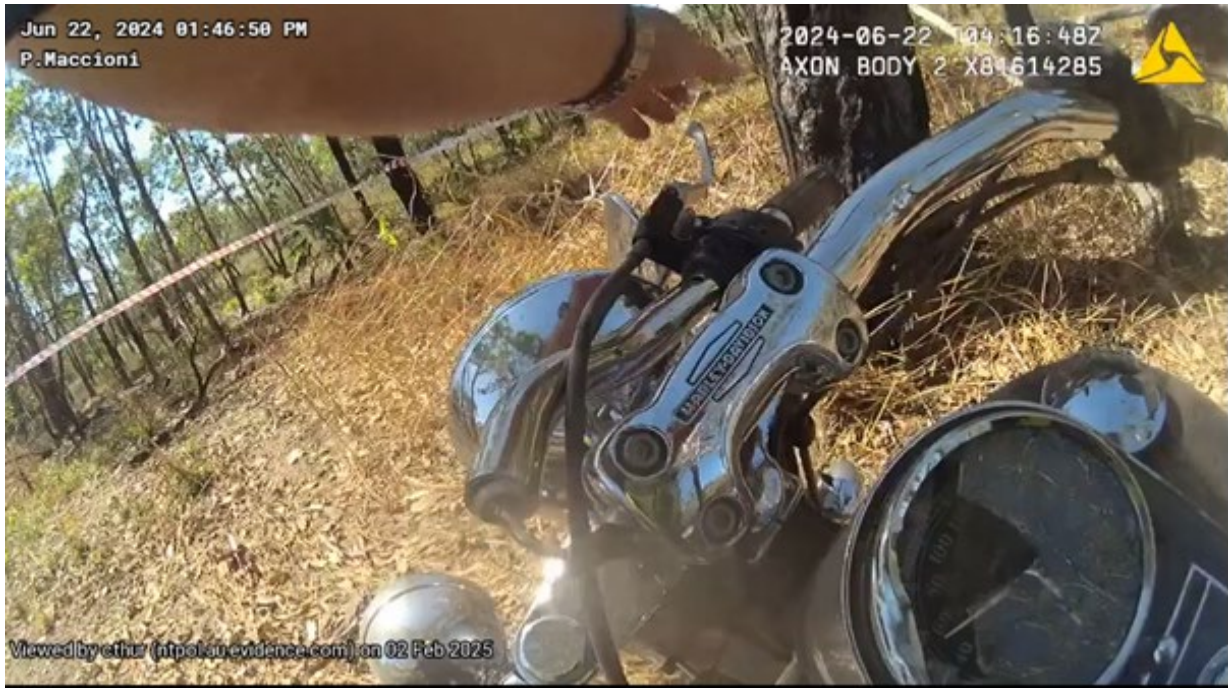
The speedometer stuck on 57km/h.

The scene was photographed, measured and assessed by attending Police. No speed calculations or other tests were completed on the road surface due to insufficient evidence. The speedometer was stuck at 57km/h. This did not indicate that the crash occurred at 57km/h, rather that the speedometer stopped on that speed.

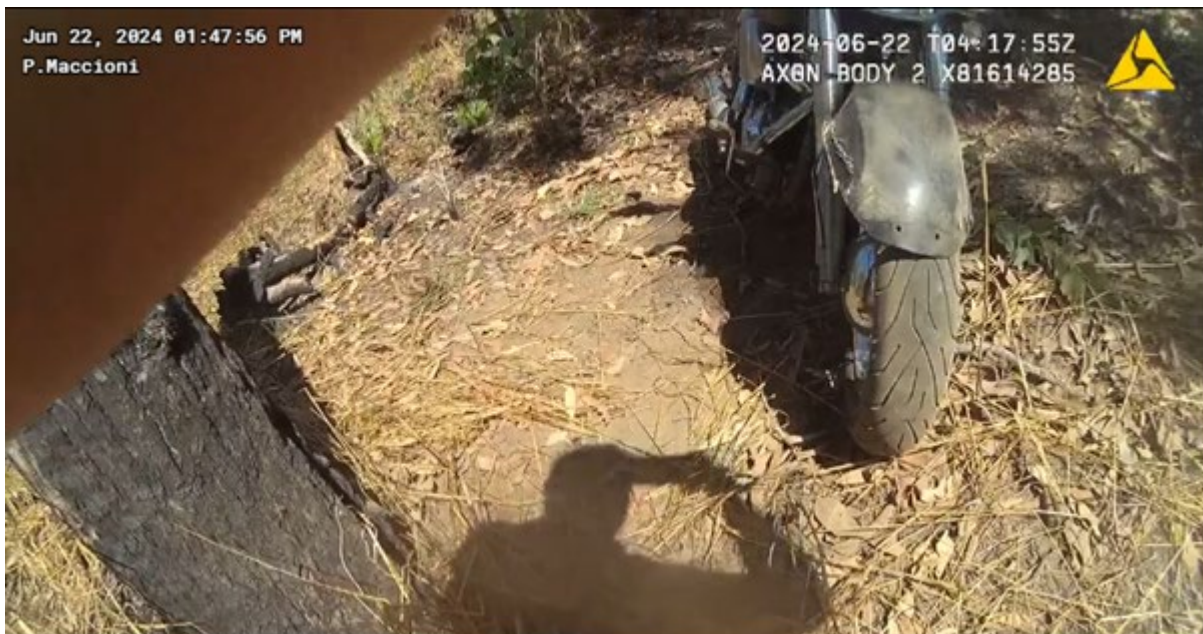
The front tyre in good condition.

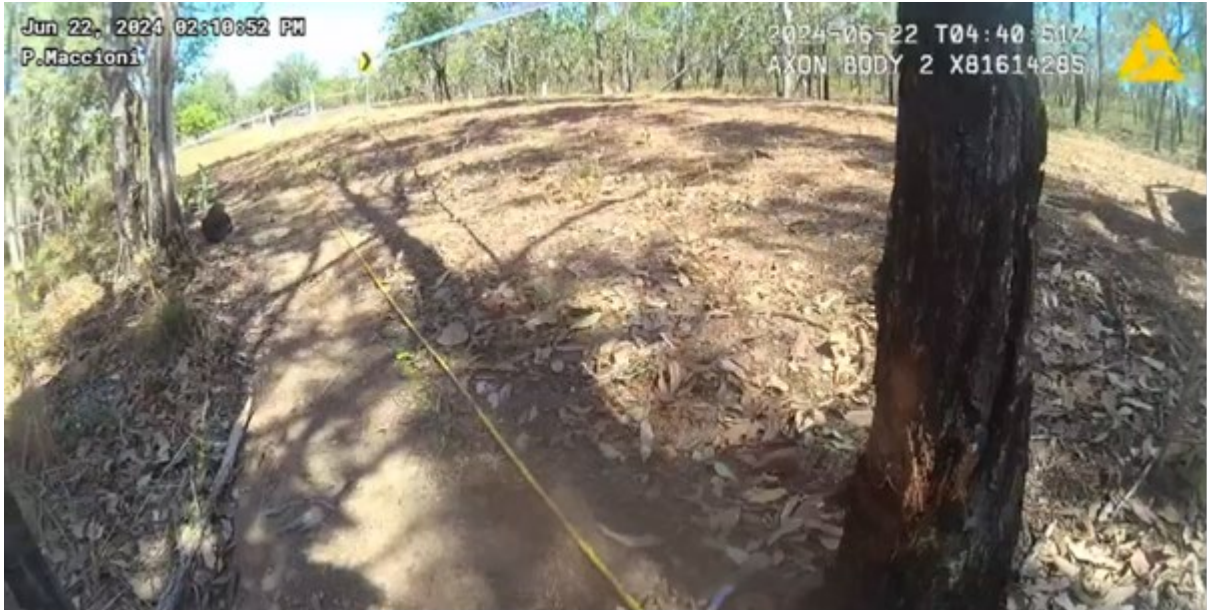
From the crash site looking back up to Litchfield Park Road, the path the motorcycle travelled as it left the road. A large gouge mark can be seen on the tree trunk to the right.

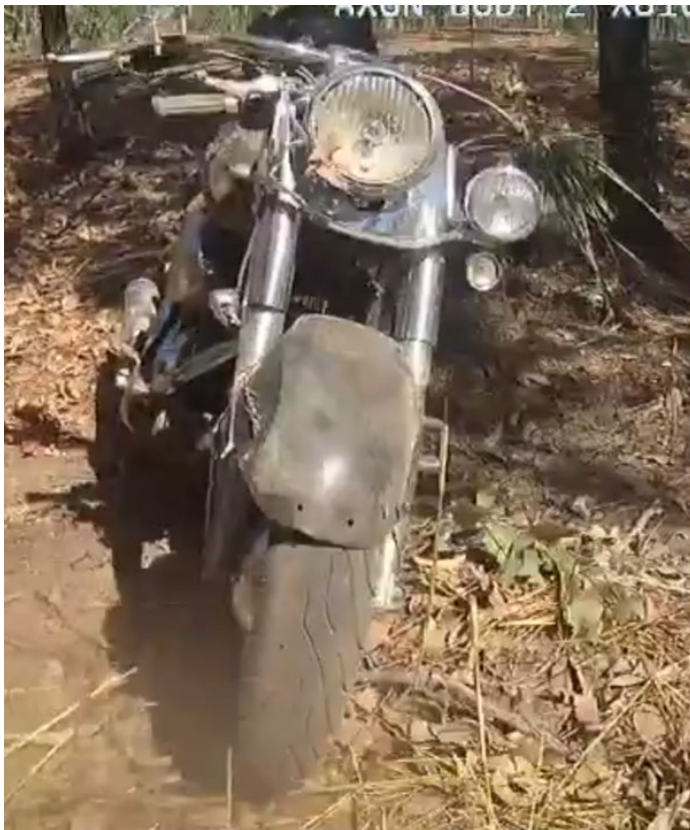
Front forks appeared intact. Front tyre looks like it lacks tread, but this could be due to the bike sliding on the gravel verge of the road when it tipped and skidded.

Afront wheel wobble, also known as a 'head shake', can be caused by a combination of factors, including incorrect tyre pressure, uneven weight distribution, bad wheel bearings, poor rear suspension, or worn-out tyres.

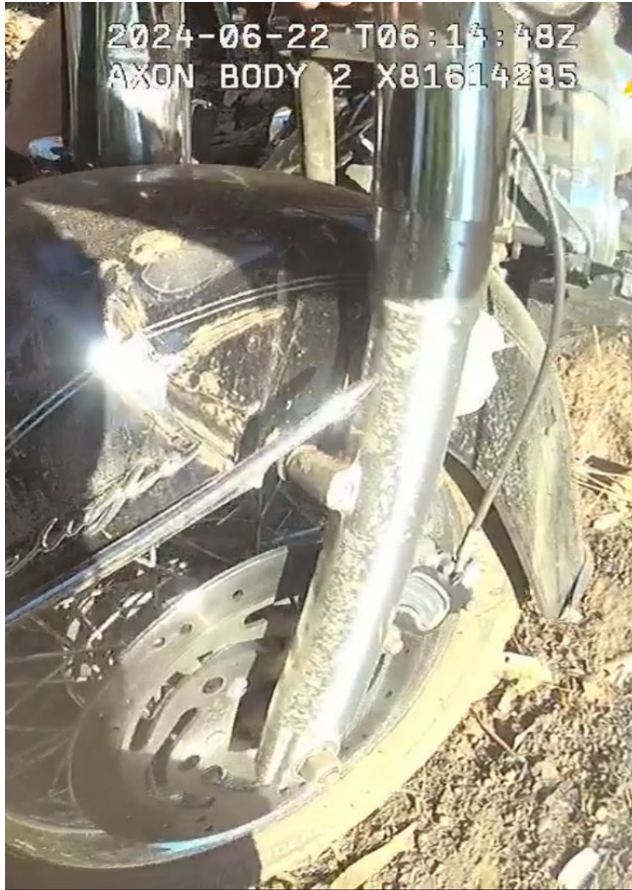
Forks extended.
