# IN THE CORONERS' COURT OF THE NORTHERN TERRITORY

## CORONERS' FINDINGS

### ROAD DEATH 18 OF 2024

I, Elisabeth Armitage, Coroner, having investigated the death of a **29-YEAR-OLD CAUCASIAN FEMALE** and without holding an inquest, find that she was born on **18 March 1995** and that her death occurred on **29 March 2024, at Melville Bay Road, Nhulunbuy in the Northern Territory.**

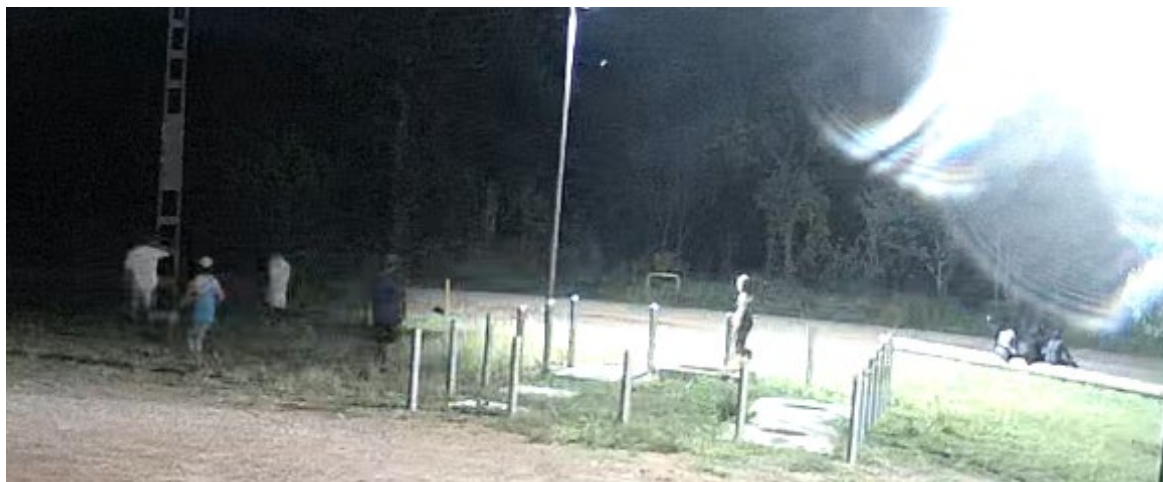
Still taken from CCTV, some of the group exiting the main driveway

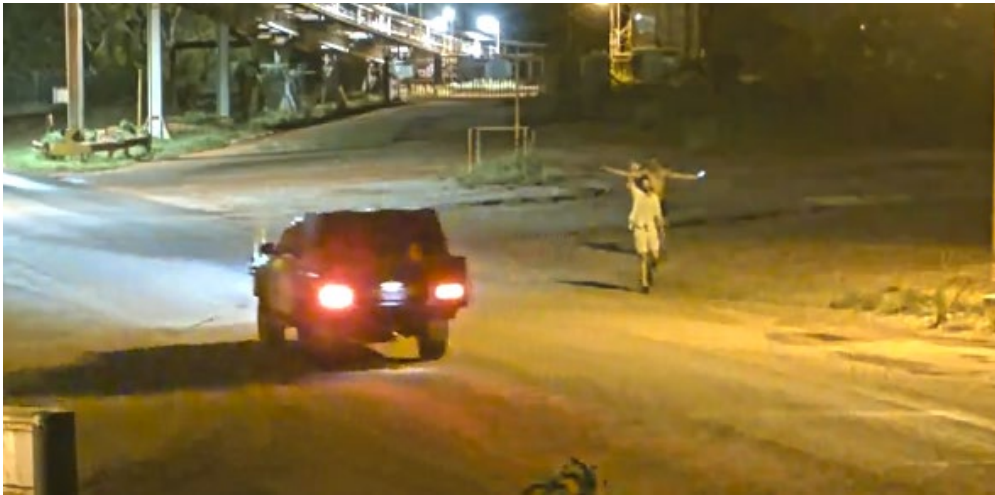
Still taken from CCTV, other pedestrians trying to wave down a car for a lift near the Rio Tinto conveyor

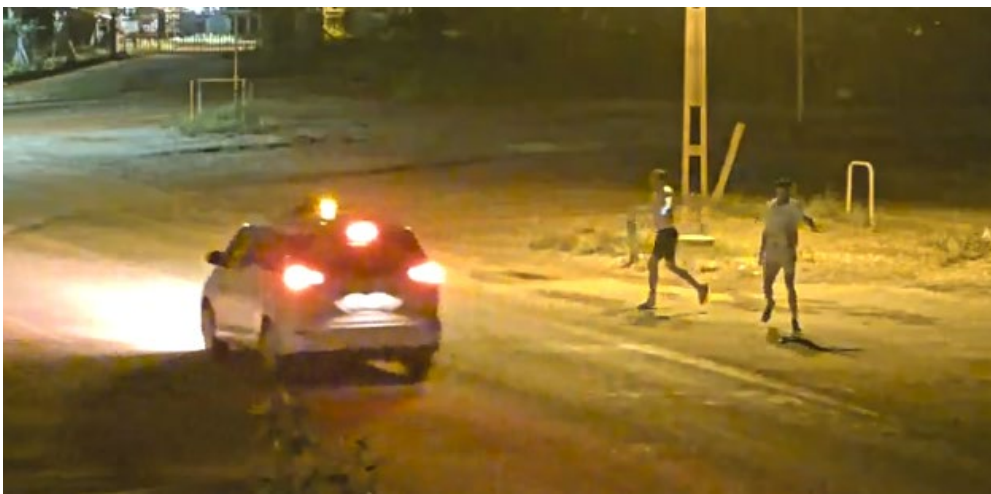
Still taken from CCTV, other pedestrians trying to wave down a taxi

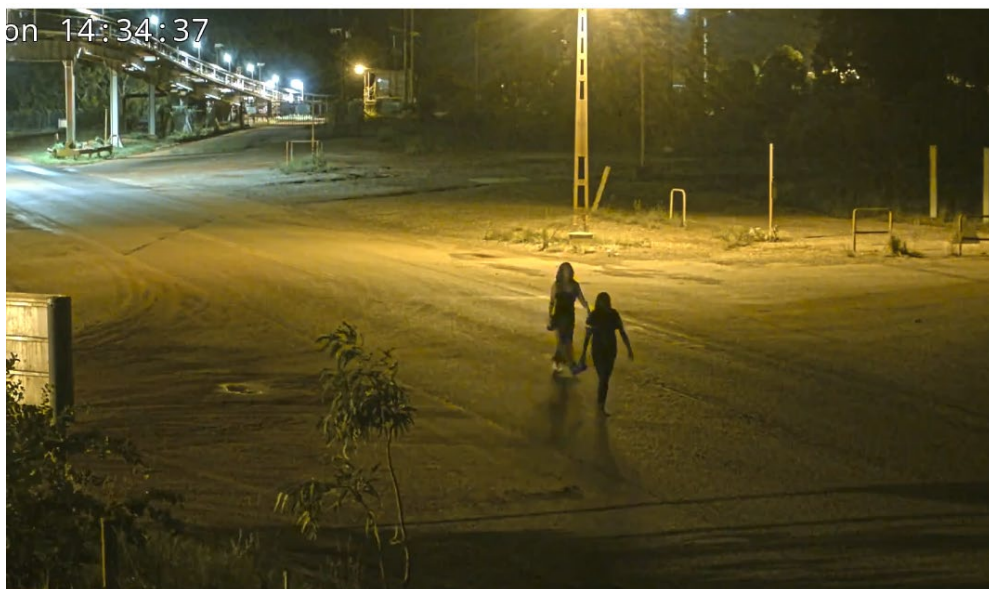
Still taken from CCTV, the deceased, and her friend walking down the road near the Rio Tinto conveyor

Just before 12.24am, the 29-year-old was now walking inbound (in the direction of Nhulunbuy) in the inbound lane while her girlfriend was slightly ahead of her and still walking on the edge of the outbound lane. There was no street lighting, and it was very dark. Witnesses described the lighting as "really bad along that stretch." The girlfriend used her phone torch to see, but the 29-year-old did not use any light. The 29-year-old was wearing darkish pants and a dark singlet.

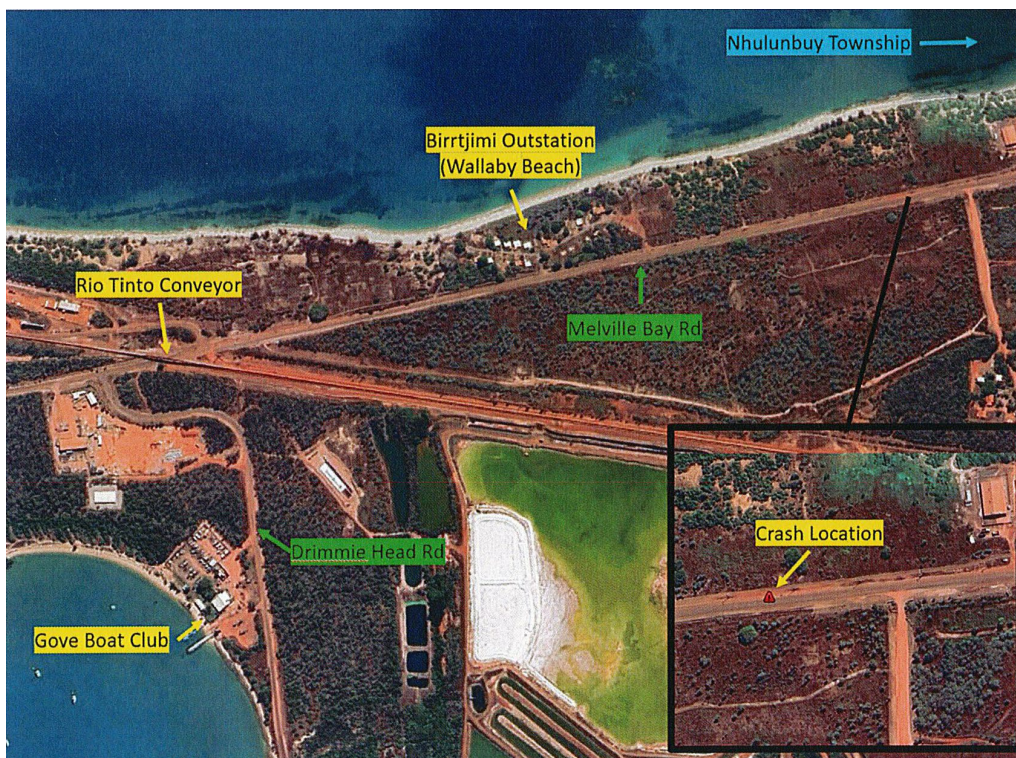
Crash location, Google Earth Image, and Police Investigators markings

The collision occurred on a straight sealed section of Melville Bay Road approximately 750 metres east of Wallaby Beach Outstation. The in-and-outbound lanes are delineated with a broken white centre line and there was no painted fog lane marking the road edges. The road has cleared, gravel shoulders with a row of steel power poles and a footpath running parallel with it on the north side of the road. The speed limit for that section of Melville Bay Road is 80 km/h.

**I recommend to the Department of Infrastructure and Logistics**, that, together with RIO Tinto, they ensure that adequate street lighting be provided between the Gove Boat Club and Nhulunbuy to reduce the risk to pedestrians. The extent of the additional lighting is to be determined considering the known risks and the intent of the Safe System approach in the 2024-2028 Towards Zero Safety Action Plan.
