CITATION: *Inquest into the death of Xavier Nicholas Lengyel*
[2019] NTLC 005

CATCHWORDS: **Traffic collision between unregistered motorcycle and vehicle, substandard police investigation, referral back to Police and DPP**

In the matter of an Inquest into the death of
XAVIER NICHOLAS LENGYEL
ON 14 MARCH 2018
AT LEONINO ROAD, DARWIN RIVER

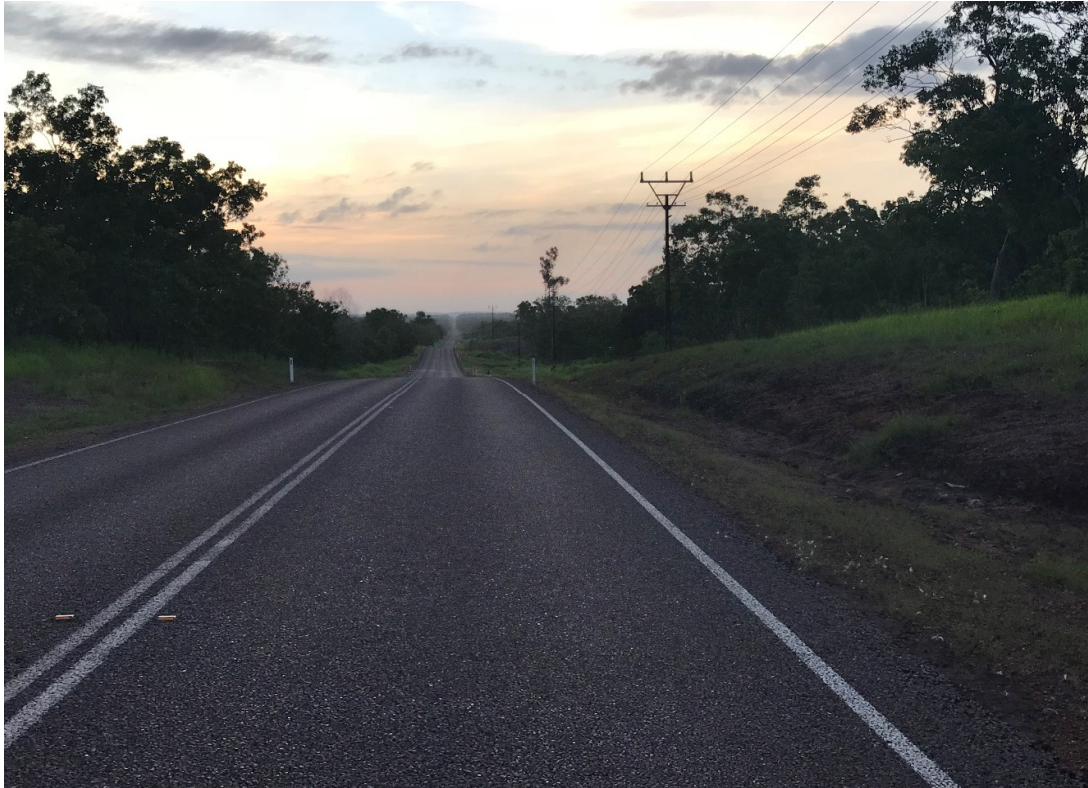
Image 2 - looking west down Leonino Road in the late afternoon

42. That view omitted to take into account that, as readily seen from the photographs, there is a second crest that obscures visibility from the top of the hill.

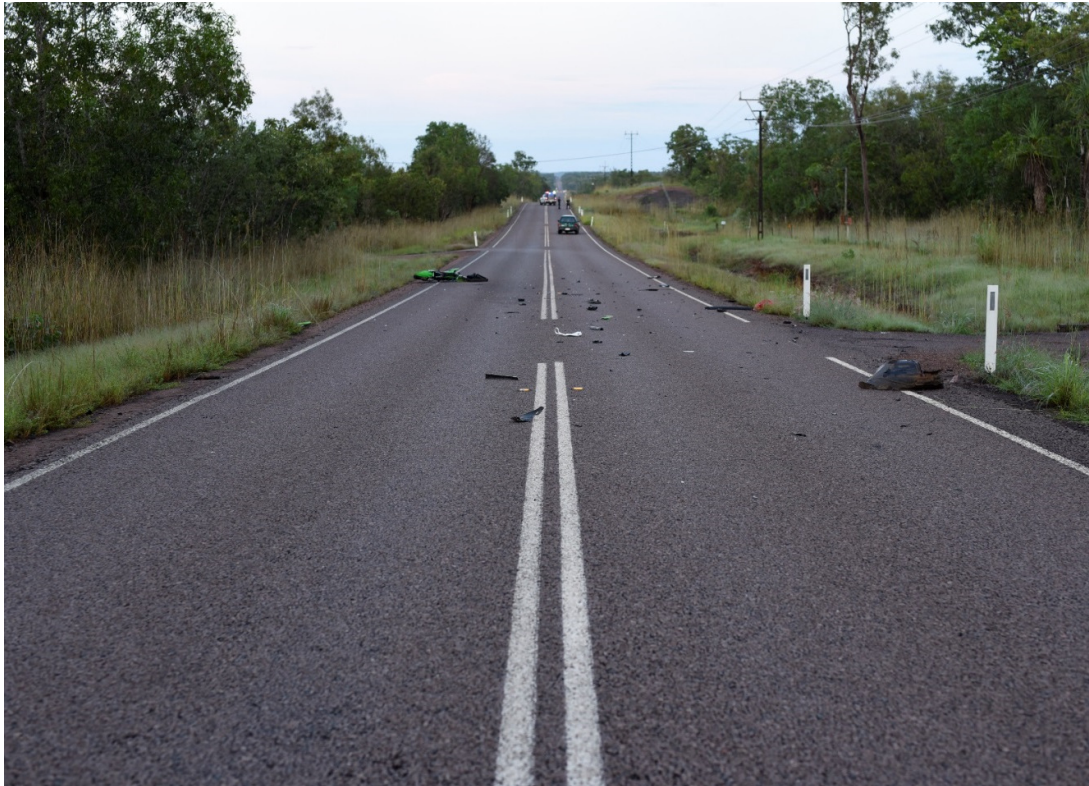
Image 3 - scene of collision

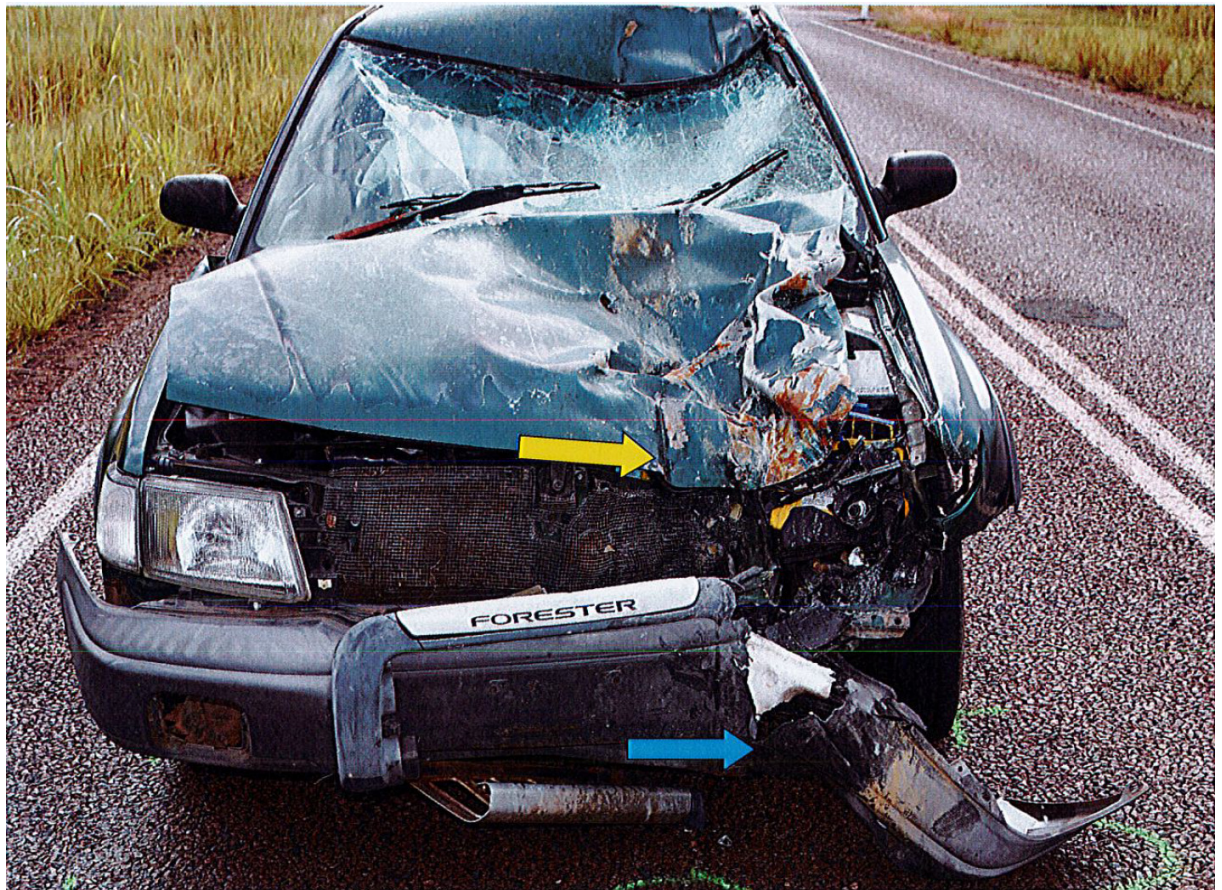
Image 4 - Image and explanation from Police Crash Report.

36. Examination of the motorcycle confirmed to investigators that it had not been doing a wheel stand at the time of impact. There was extensive damage to the front wheel and forks. The Subaru also had an impression in the front bonnet from the motorcycle front fork and damage to the bumper bar considered by investigators to be caused by the motorcycle front wheel.

Image 1 - Yellow arrow indicates impression in bonnet from motorcycle front fork. Blue arrow indicates damage caused by motorcycle front wheel

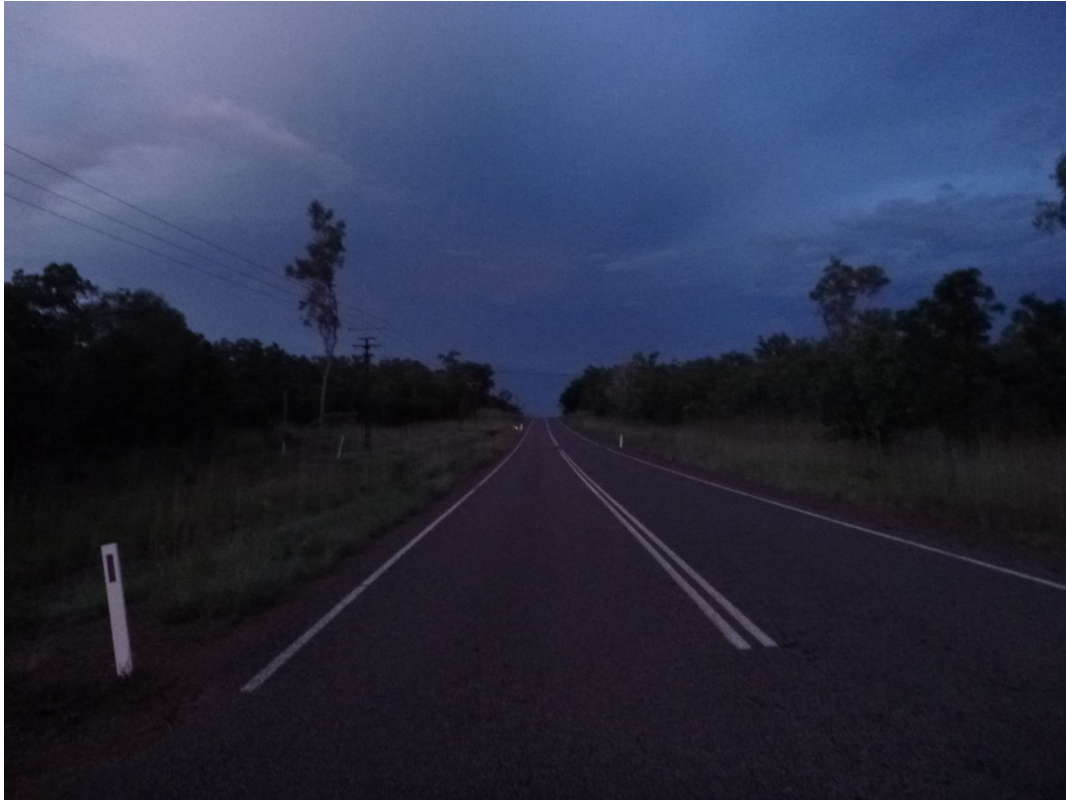
50. During the course of the Inquest the young man said that the level of light was similar to the following photograph.

Image 5 – looking up road from about where the Subaru stopped after the collision to the top of the hill
