IN THE CORONERS' COURT OF THE NORTHERN TERRITORY

CORONERS' FINDINGS
ROAD DEATH 30 OF 2024
Section 34 of the Coroners Act 1993

I, Elisabeth Armitage, Coroner, having investigated the death of a **22-YEAR-OLD ABORIGINAL MALE** and without holding an inquest, find that he was born on **21 August 2001** and that his **death occurred on 22 June 2024, at Larapinta Drive, Hugh in the Northern Territory.**

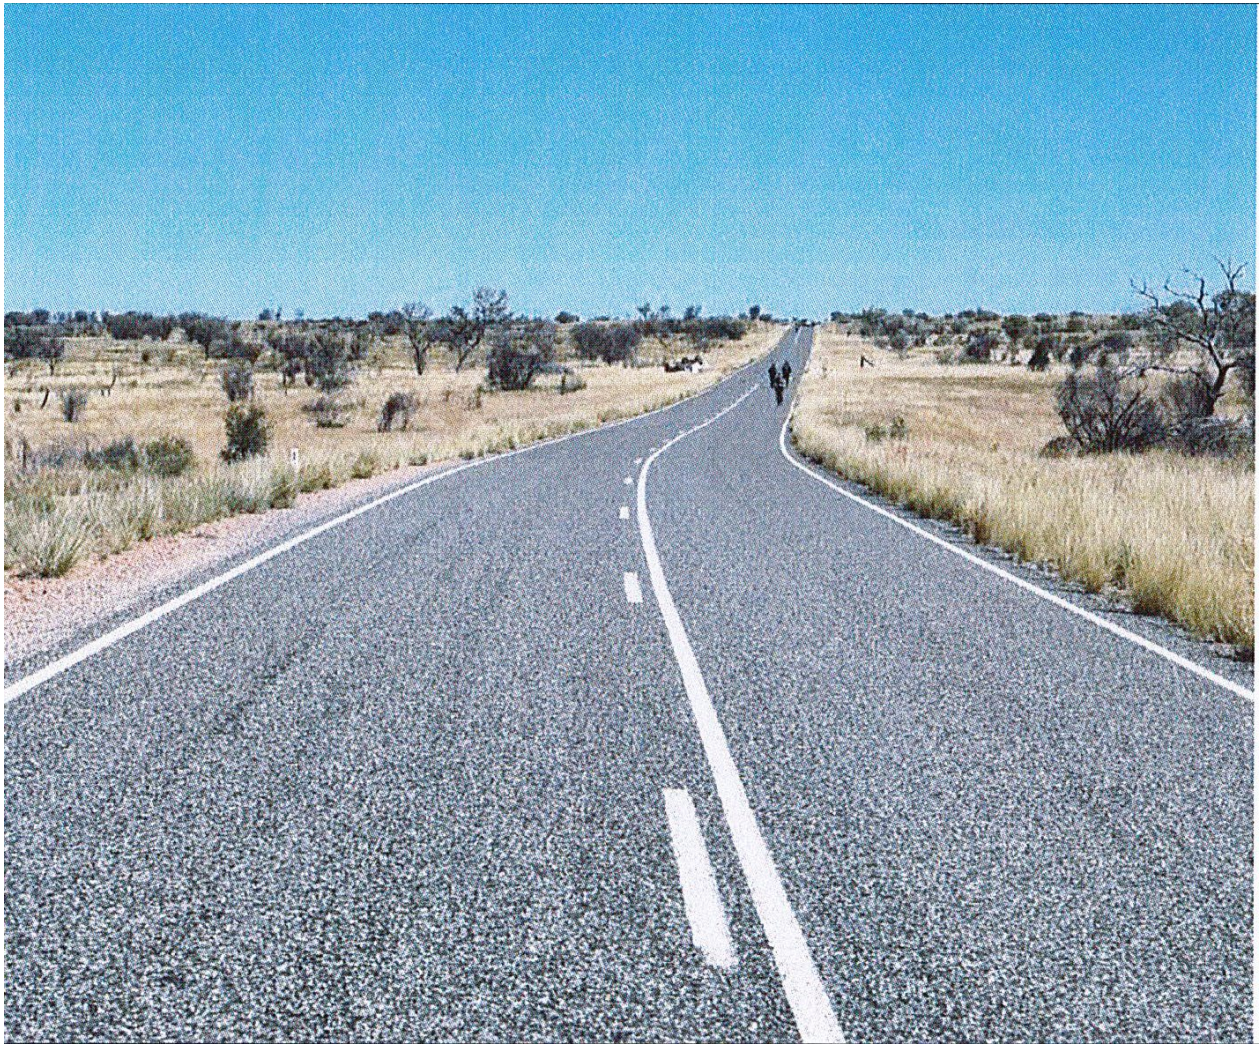
The crash occurred on a remote section of road. The speed limit was 110kph. At the time of the crash, it was night-time and there was no street lighting. The weather was fine, clear.

The road surface was 2 coat sealed asphalt, with no signs of damage or decay. The road was divided by a broken white and solid centre lane line, so traffic heading inbound to Alice Springs could not overtake. It was a long straight section of road that was defined with solid unbroken outer fog lines inside a small shoulder. There was a further small, graded shoulder before a drop off to a large, grassed area with some scattered shrubs and grasses. The stretch of road is depicted in the below photo (courtesy of Major Crash).

Scene evidence revealed that the Hilux entered a slight right-hand bend outbound on Larapinta Drive, over a crest into a slight right downhill gradient. The driver failed to negotiate the bend causing the two left side tyres to contact the gravel shoulder next to the left lane fog line. The right two tyres remained on the asphalt. To regain control of the vehicle, the driver sharply turned the steering wheel to the right. This caused the rear wheels to move out of line with the front wheels causing the vehicle to drift into a right sideways skid. The driver again tried to regain control of the vehicle and turned the steering wheel sharply to the left to re-enter the road. This caused the vehicle to commence a right-hand side skid or critical yaw, and it traveled sideways. As the Hilux moved sideways it tripped and rolled violently. It struck a concrete culvert and drain and then rolled sharply to the left. The vehicle rolled for approximately 150 meters before coming to rest on the correct side of the road.
