IN THE CORONERS' COURT OF THE NORTHERN TERRITORY

CORONERS' FINDINGS
ROAD DEATH 40 OF 2024

Section 34 of the Coroners Act 1993

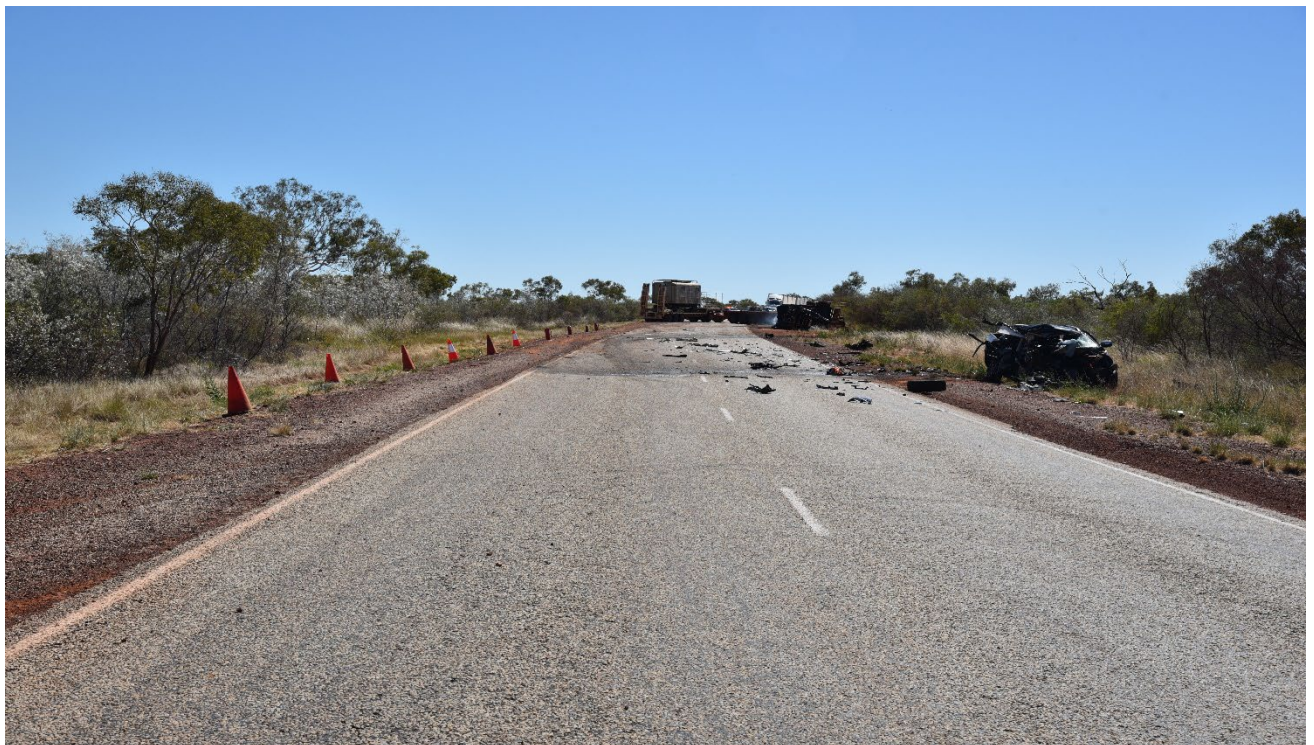
The contact damage visible at the front of the driver's 4 x 4 utility showed that approximately 1.2 metres of the utility made impact with the front of the road train. The point of impact was approximately in the middle of the northbound lane, so the driver was on the wrong side of the road at the point of collision.

Tyre marks left on the roadway indicate the truck driver moved left in an unsuccessful effort to avoid the crash when the driver encroached into his lane. The truck's right steer wheel exploded and the momentum of the heavy trailers caused the prime mover to roll. A fire started in the truck but the driver was able to escape.

The prime mover ended up 114.53 metres from point of impact and the 4x4 utility ended up 10.87 metres from point of impact.

An occupant in a vehicle that stops suddenly (on impact with the truck), automatically resists the standstill due to inertia. The body continues to travel forward until stopped by an external object, normally a seatbelt. The driver was not wearing his seatbelt and hit the steering wheel and dashboard. The severity of his injuries reflect the severity of the impact.
